City of El Segundo Recreation, Parks and Library

Subject: Pine Tree, Library Park

LIBRARY PARK
Certified Arborist Report

February 19th, 2025

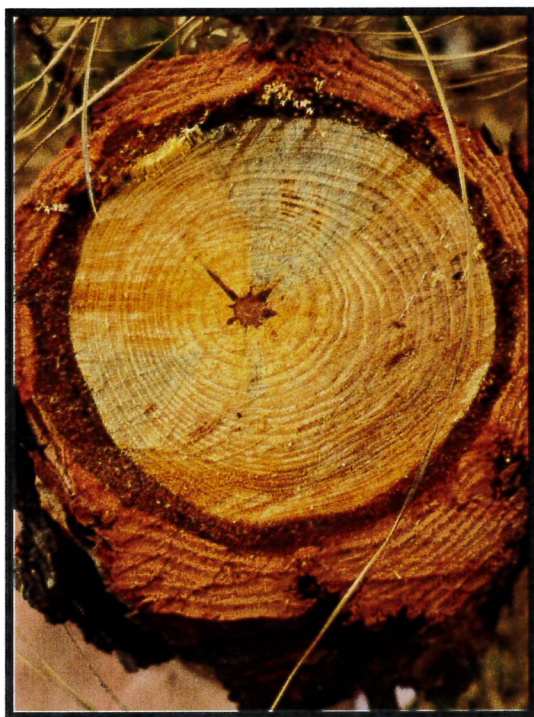
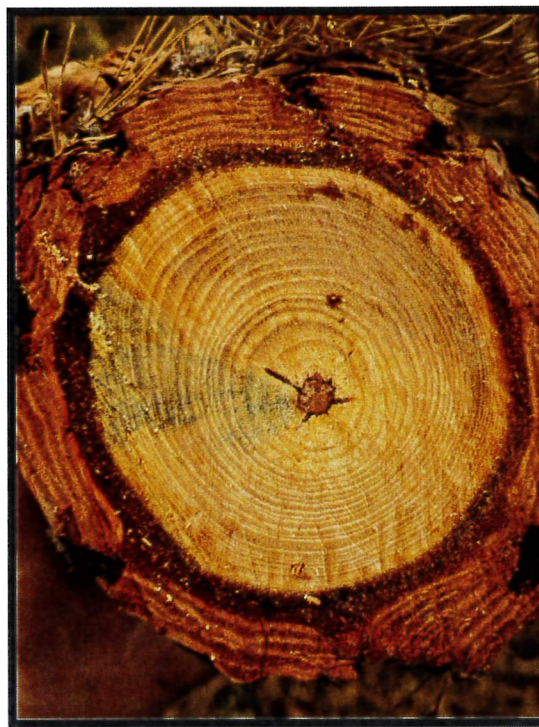
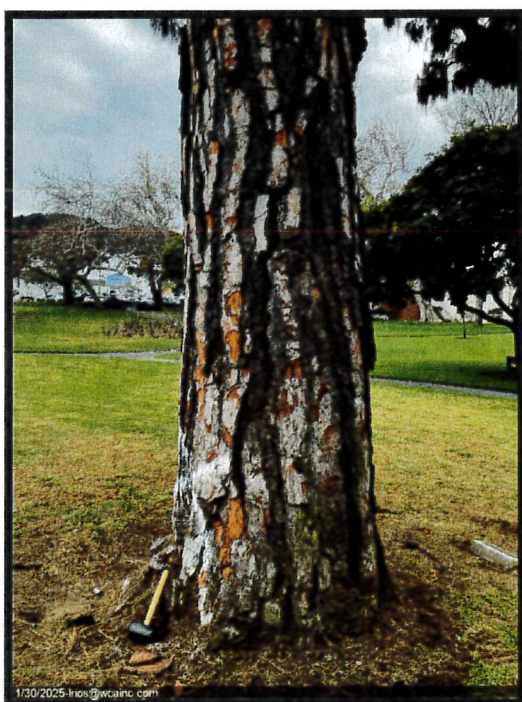
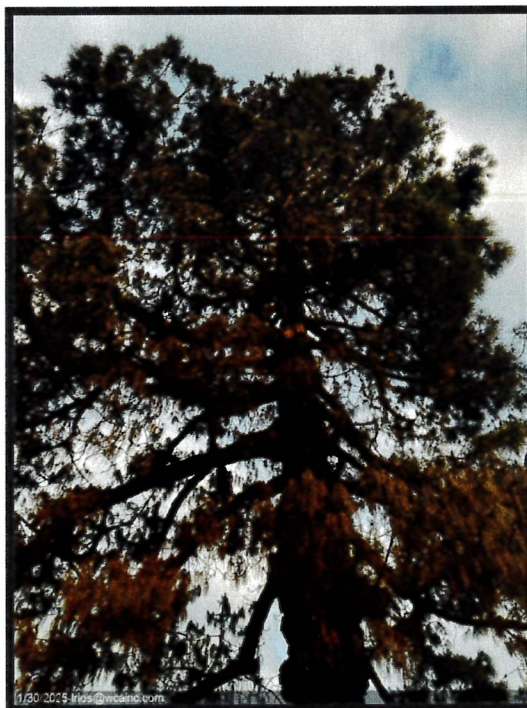
The inspected tree included one Canary Island Pine tree (P-40) which began to exhibit signs of decline in May 2024 per the use of google earth satellite imagery and verbal confirmation from the city. The focus of this general health assessment was to report on the overall health and provide maintenance recommendations. The majestic 95-year-old pine tree is over 60 ft tall and has a DBH of 42 inches, it is situated at Library Park, near Main Street in a grassy open space. Unfortunately, the majority of the canopy, approximately 80%, is dead and the tree will most likely not regain health.

When the trees' lower trunk, 4ft upward from the base, was sounded with a carpenter's mallet, tonal differences were observed. This, coupled with the peeling bark and slight swelling of the trunk indicates possible decay. The surrounding grass lawn appears to be inconsistently irrigated per the aggregates of dead grass observed and when probed with a moisture meter. Upon observation through the use of binoculars and a hand-held lens, no frass or holes, due to wood-boring insects was apparent. During sampling of the lower limbs, I observed blue staining and cankerous tissue in cross section cuts and upon laboratory analysis, blue-stain fungi was confirmed.

Additionally, upon investigation utilizing Arbor Access, Canary Island Pine P-32, about 50 feet or so to the northwest of the subject tree P-40 appeared to be in decline in 2019 and was removed in March 2023. It started with scattered dying branches that later became canopy-wide yellowing, severe thinning and death. On P-40 (subject tree) I did not observe frass from bark beetle damage, so the suspect is internal decay of the roots or lower trunk tissue coupled with my observations above.

There are multiple kinds of root diseases that can be transmitted through root grafts from adjacent trees. P-40's (subject tree) roots were very likely intertwined with P-32's. The park graded that P-32 was in an area where copious amounts of water accumulated at its base and the soil is probably poorly drained. The park slopes from west to east towards Main St. and P-40 is not much higher than the previous P-32, it is a little lower in fact, so water accumulation is highly likely and as such:

- It could be *Armillaria* root rot, which is entirely possible after two very wet winters which left the soil saturated for long periods of time, perfect for root rot.
- *Phytophthora* is possible or
- It could also be something more uncommon like *Heterobasidion* root disease

Images 1-4. Sample photos of the subject tree, P-40, additional photos can be found in Arbor Access.

Further investigation of the roots and viewing the tissue when the tree is removed is highly recommended, especially if it was a root rot in combination with a fungal problem like blue stain fungi. It would be necessary to get a better understanding of the cause. If Blue Stain fungi was present but not vigorous enough to kill it, then root rot may have been the culprit.

- **REMOVAL- DEAD TREE OR DISEASED/DECLINING TREE**
 - The tree should be prioritized for removal as it is dead or in severe stages of disease/decline and not expected to regain health.
 - Due to the manner in which the decline progressed and to confirm if root rot was a culprit, I would need to examine the roots at the time of removal.
