**Office of the State's Attorney for Baltimore City  
120 East Baltimore Street  
Baltimore, Maryland 21202**

**MEMORANDUM**

**Re: Department of Public Works Pedestrian Fatality (AIU#24-60/CC#7-241102489)**

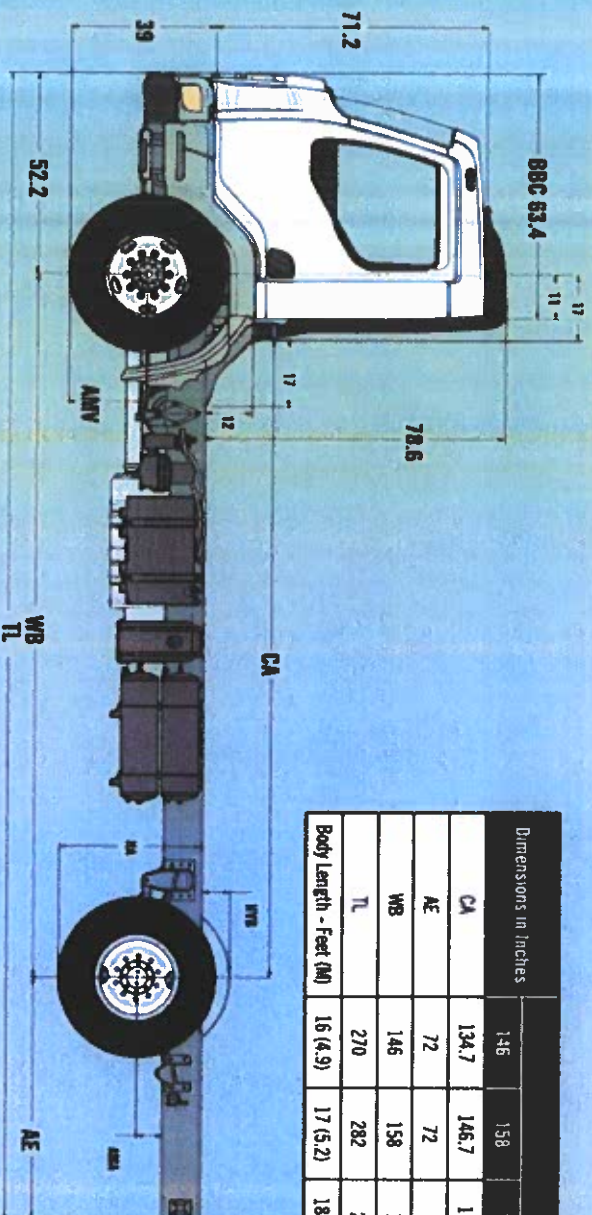
# KENWORTH K270 AND K370 DIMENSIONS

Based on the photographs in the Baltimore Police Department’s file and a site visit to examine a similar truck, it was determined the truck at issue was a 2021 Kenworth model K270/K370 (“Kenworth”) with the standard chassis configuration. (Ex. 1). The Kenworth is essentially a do it all urban vehicle. In other words, it can be configured with a cargo bed or in this case, a rear loader to function as a garbage truck. Due to its compact size, the Kenworth has what is known as a “cab over” design. Cab over vehicles can increase driver fatigue and depending on the size of the vehicle, can make it harder for a driver to hear what is going on around the vehicle. The manner in which the rear loader was installed on the Kenworth chassis was not determined.

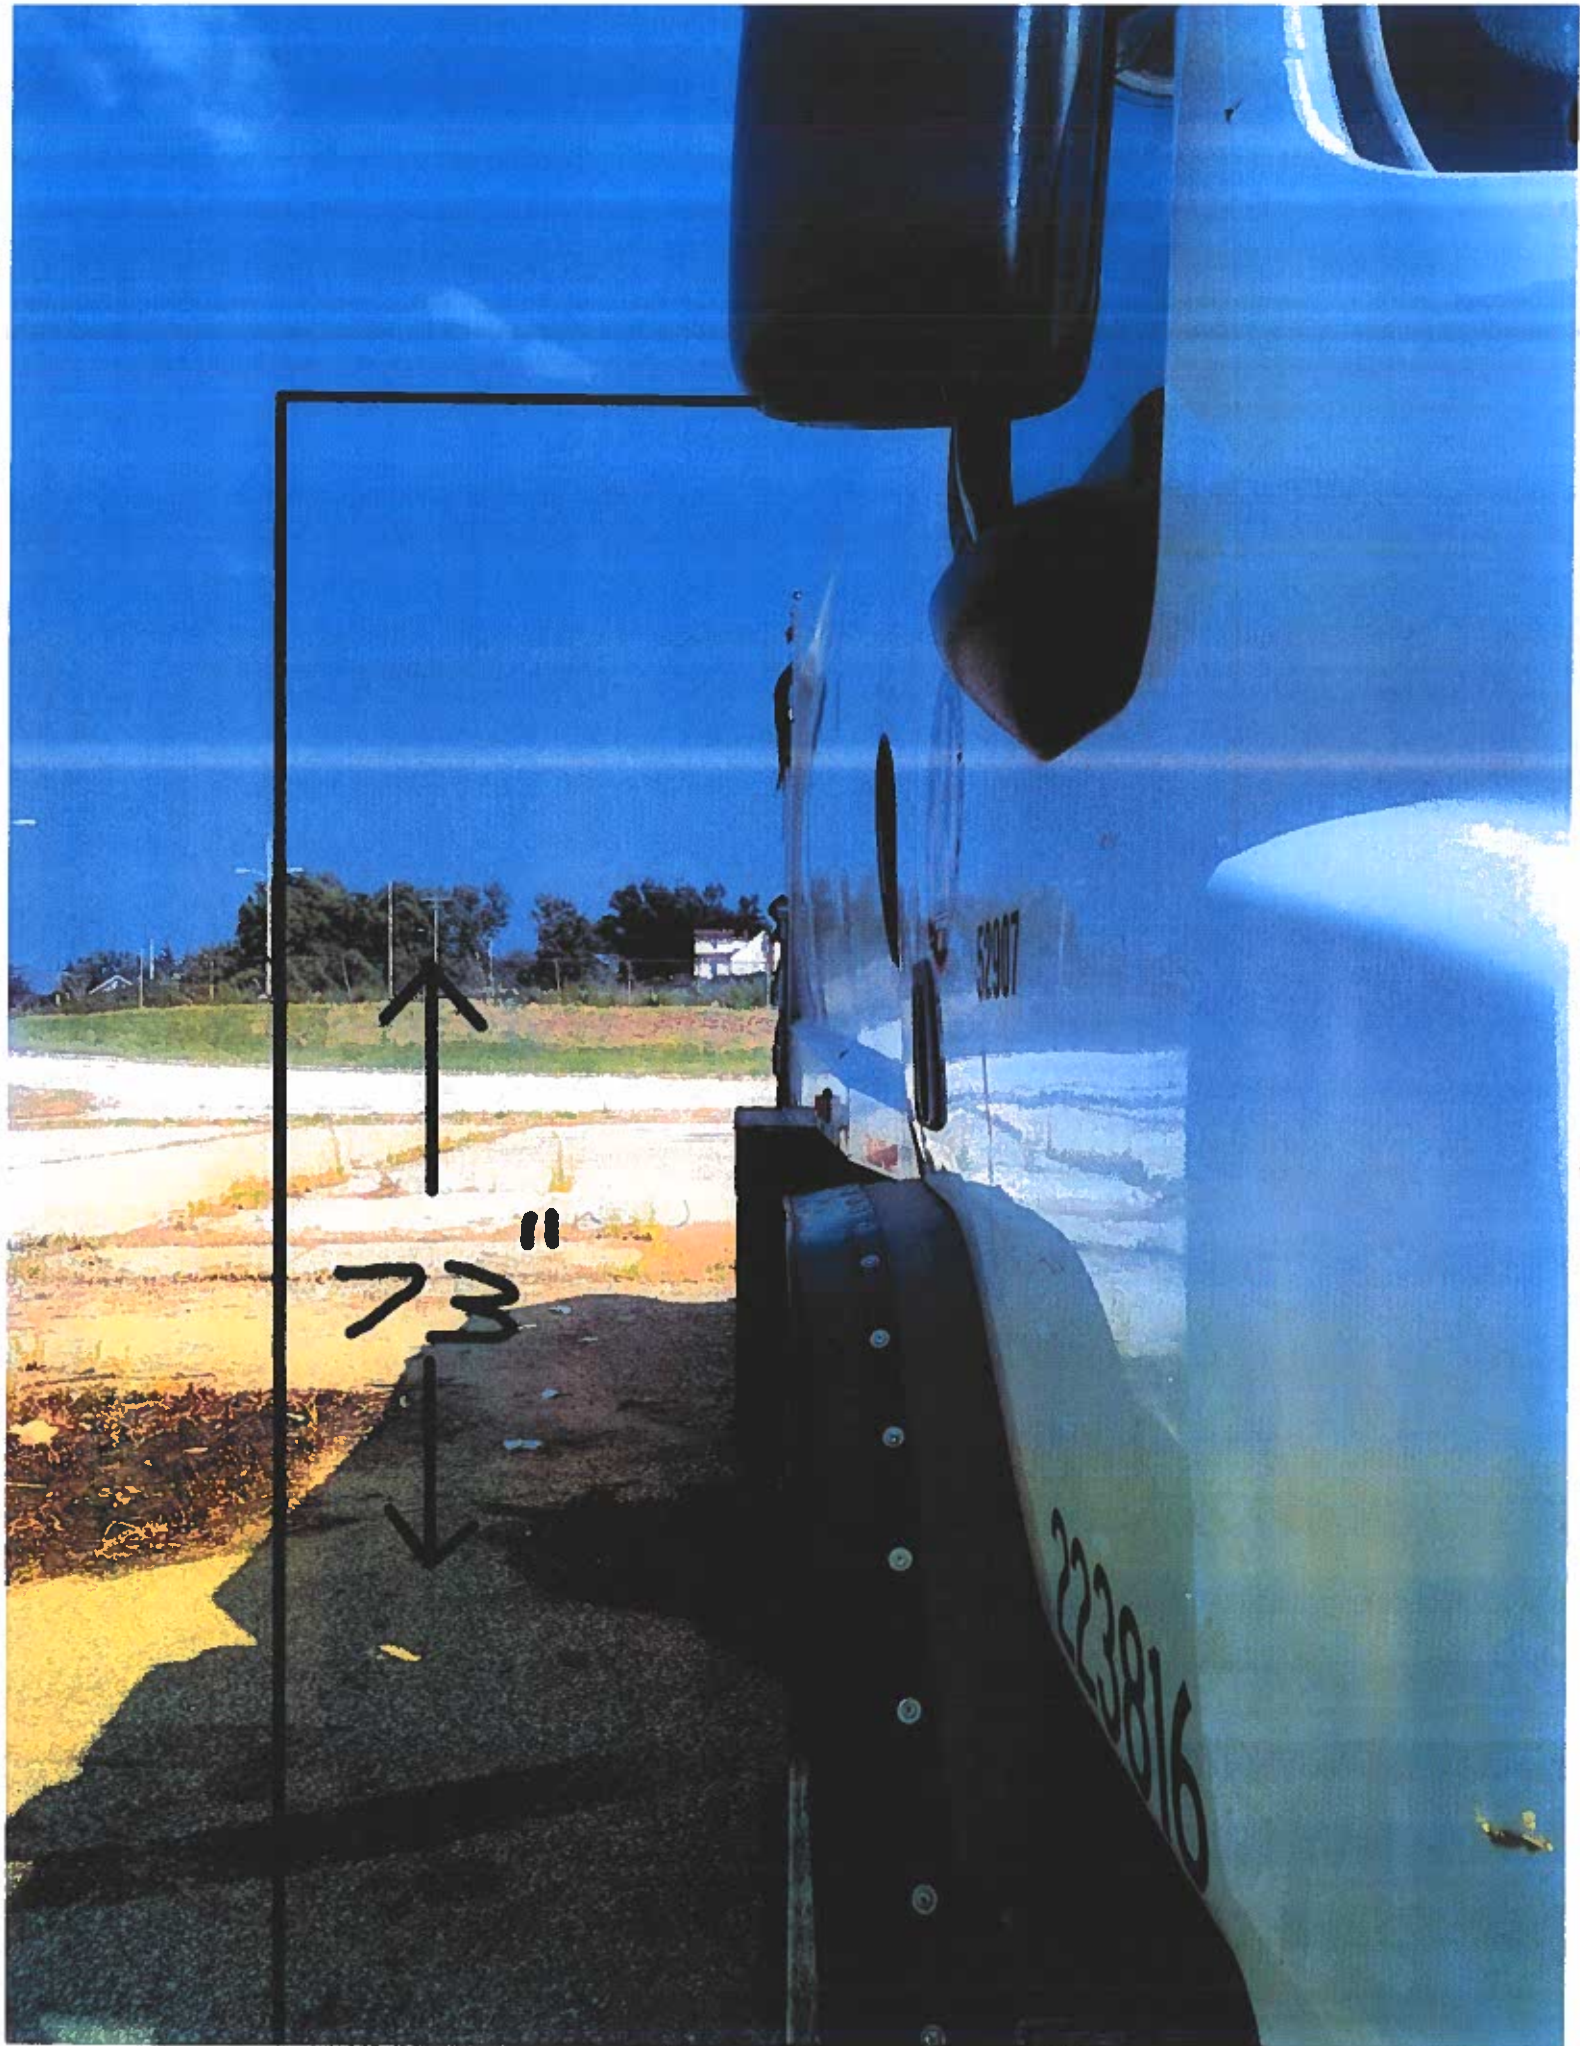
BPD - Crash Team

The alley where the incident occurred runs north to south and is extremely narrow. It measures between 9.42 feet and 10.17 feet wide in different sections. (Ex. 3). There are two telephone poles in the area of the incident that run along the southwest side of the alley, Pole Nos. 113142 & 113143. *Id.* The measurement from the east side of the alley (odd side) to the concrete base of the

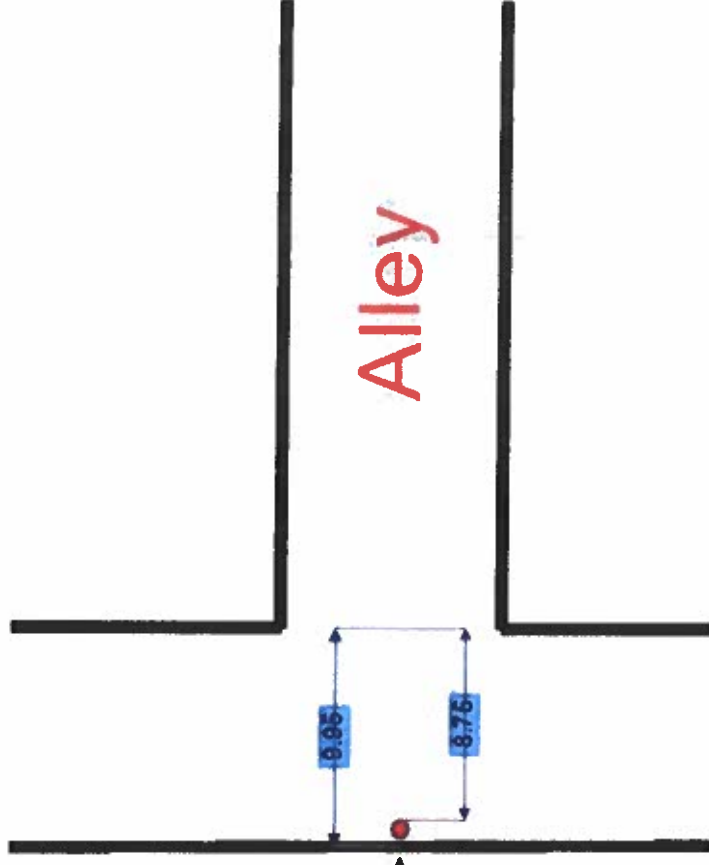
Pole #113142

west side of the alley is 9.95 feet. (Ex. 4). The measurement from the east side of the alley to the outer portion of Pole No.: 113142, the pole that at issue in this case, is 8.75 feet. *Id.* This left just 1.2 feet of space for the 7.9 foot garbage truck to pass through. (See Ex. 5 for reference). If the truck was centered, it would have just 7.2 inches of clearance on each side of the alley.
