# Current Lake Okeechobee Floating Plant Treatments: May 2019

The photos and maps below illustrate treatment locations of Water Hyacinth and Water Lettuce within Lake Okeechobee. There is an increase in native vegetation growth due to low water levels. Floating plants can shade out, smother and displace new growth. Treatment is necessary to limit ecological damage to diverse native plant communities.

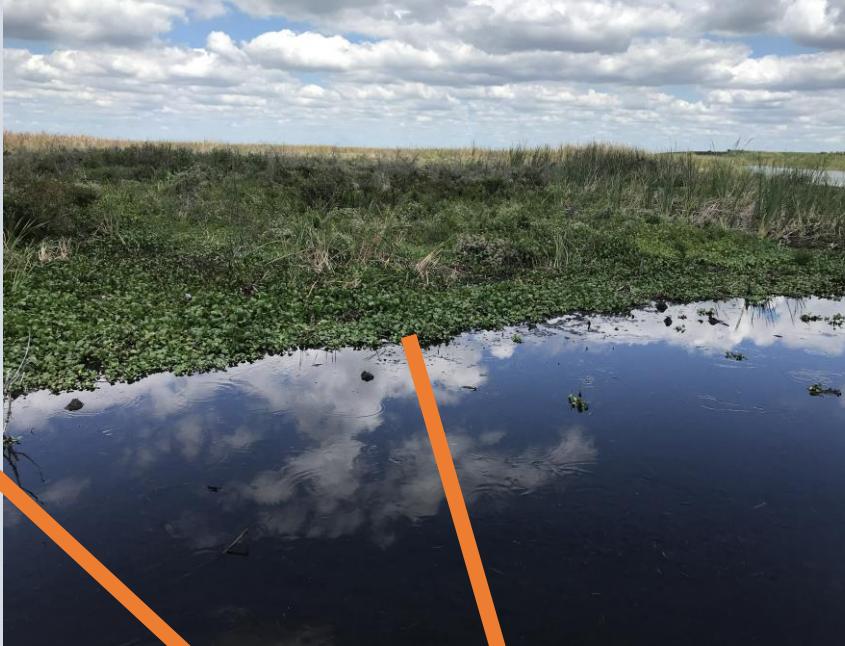
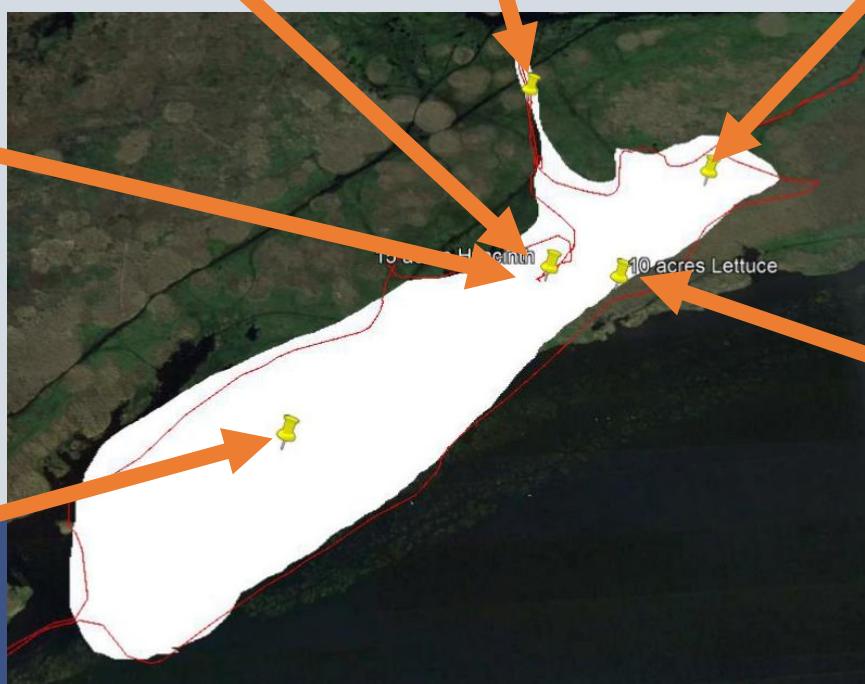
Top Left: Water Lettuce pushing out native Yellow Water Lillie and shading out Eel Grass.  
Top Right: Eel Grass growing amongst lilies with water lettuce beginning to move in.

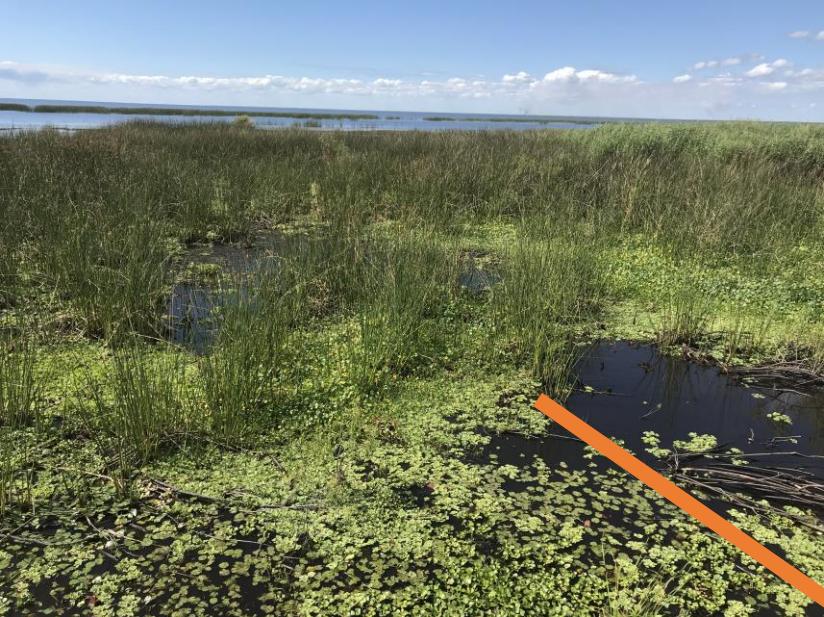
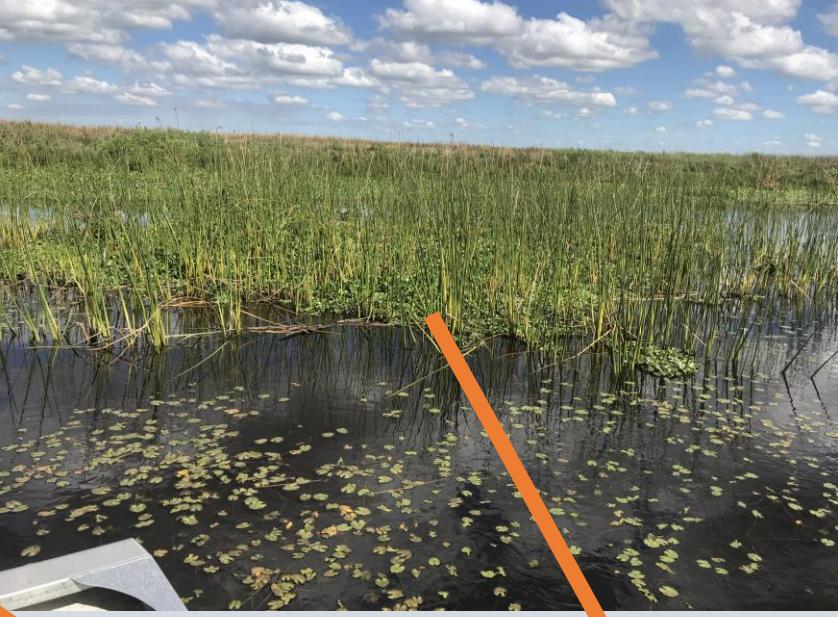
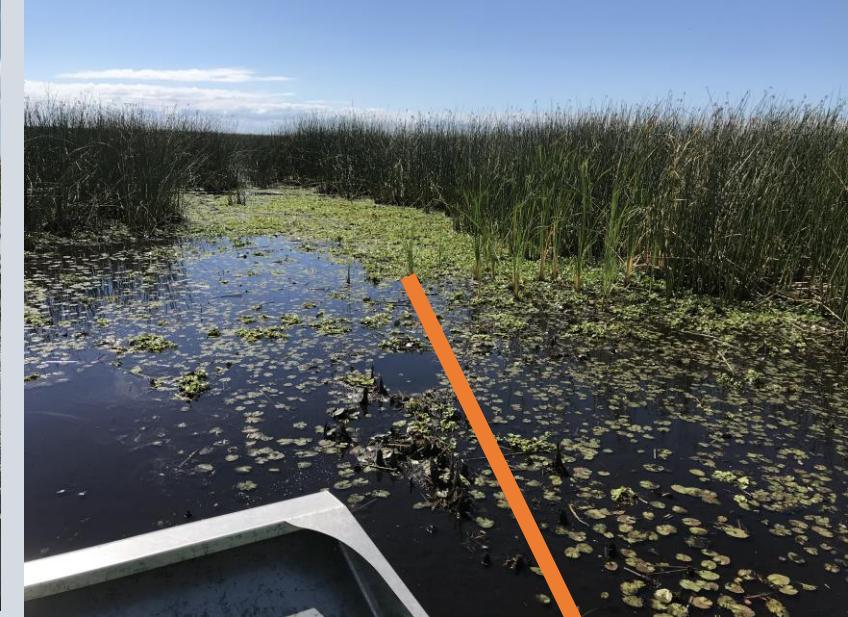
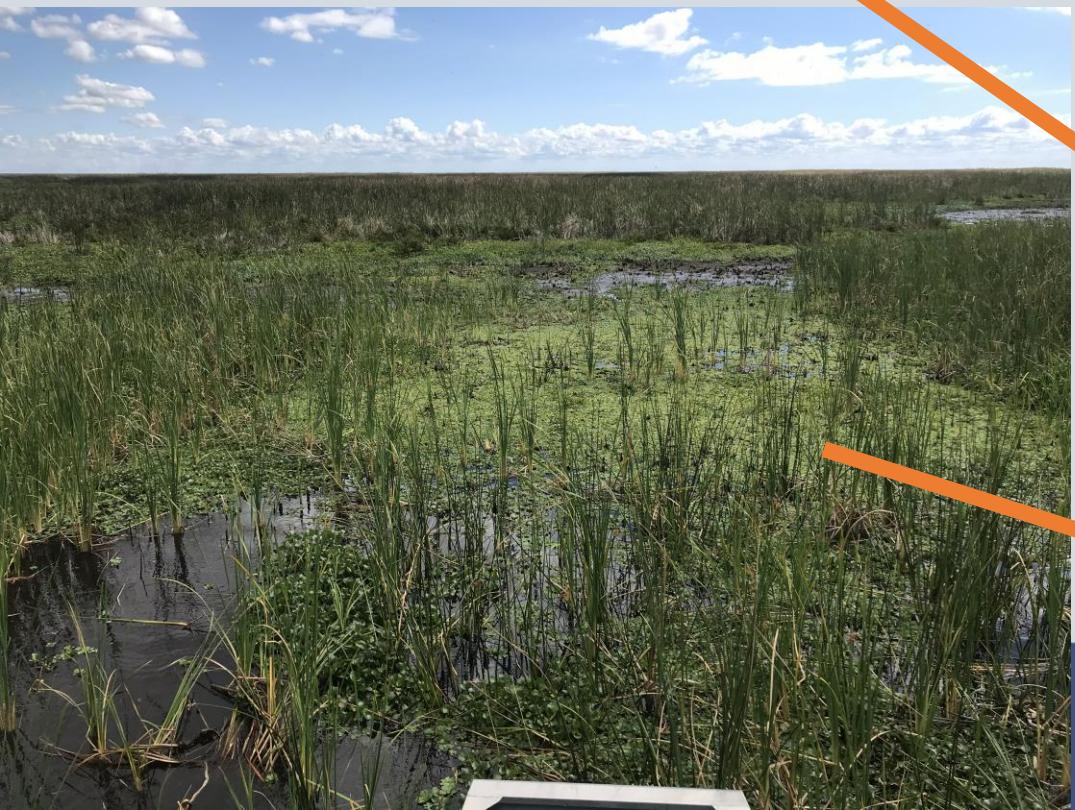
Photos showing floating plants  
mixed in with bulrush and  
cattail and currently shading  
SAV growth

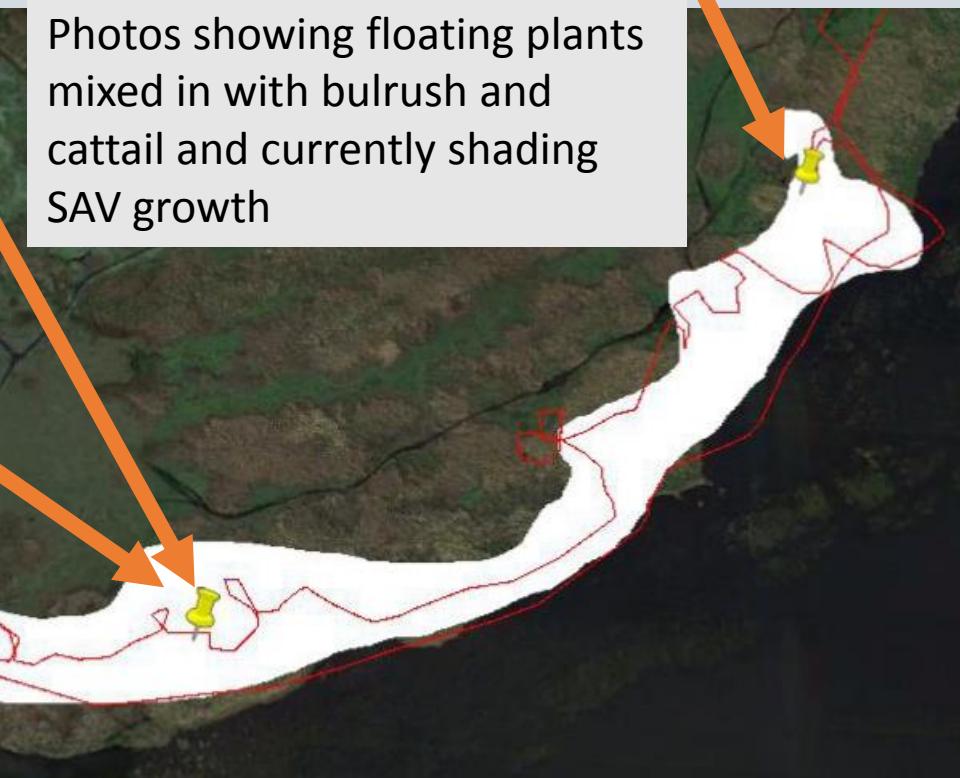
Hyacinth in this region found in 3-10 foot bands scattered along the shoreline

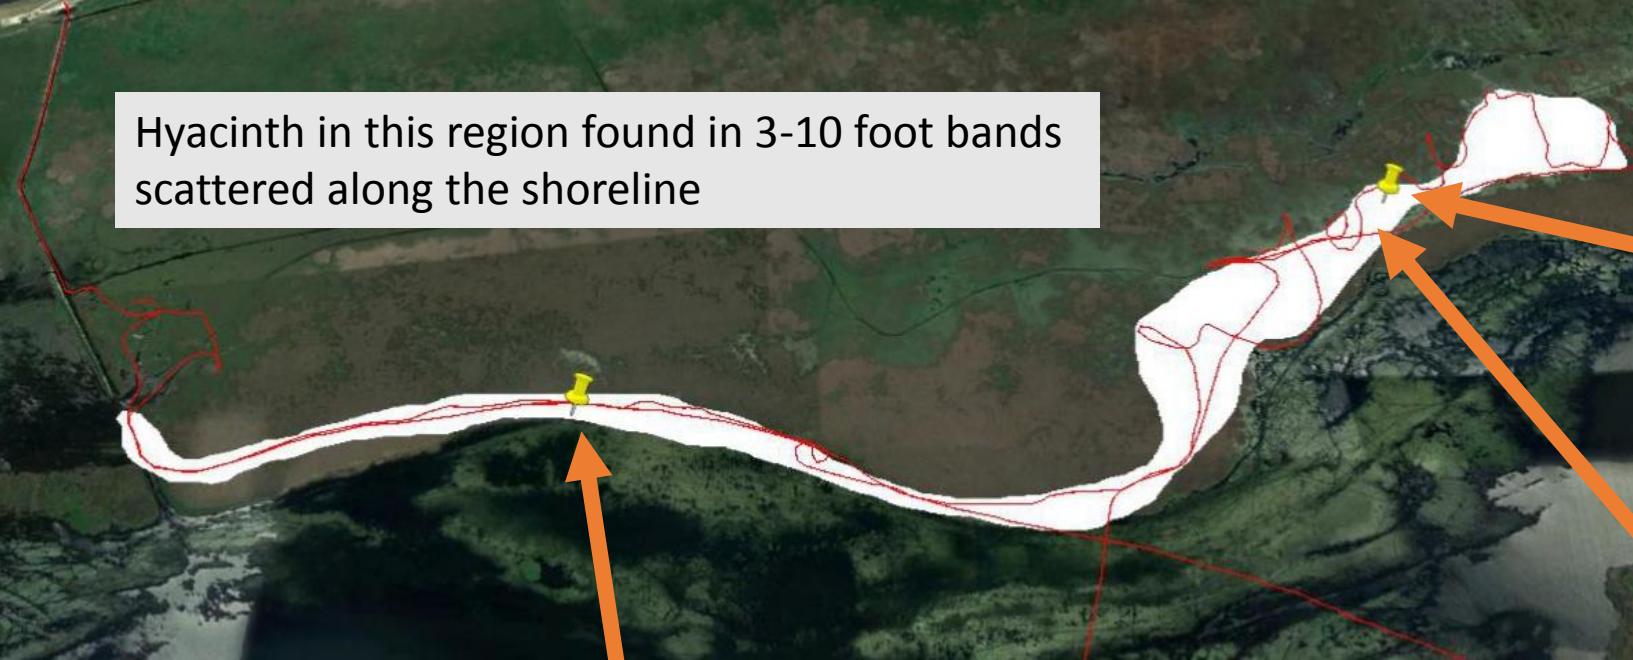
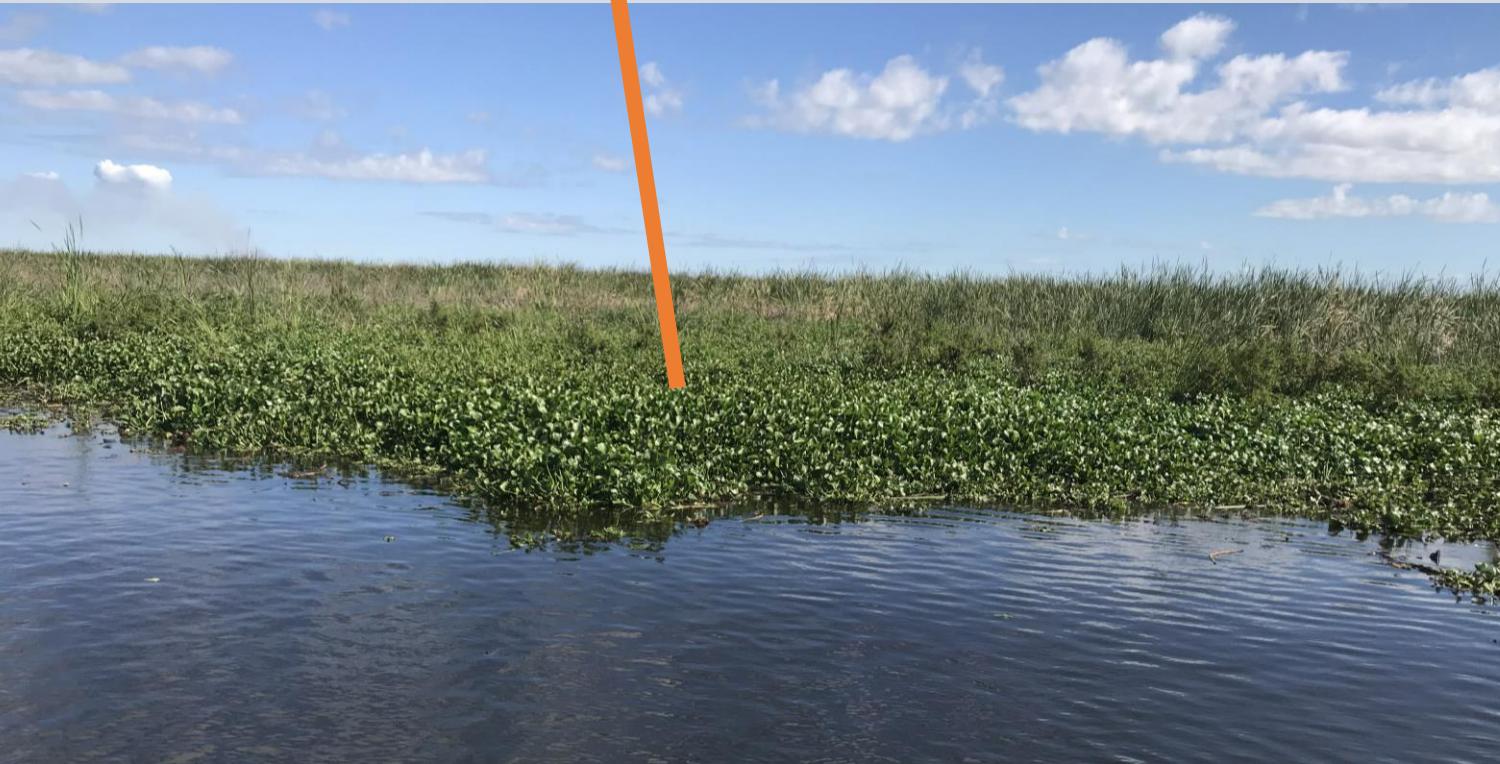
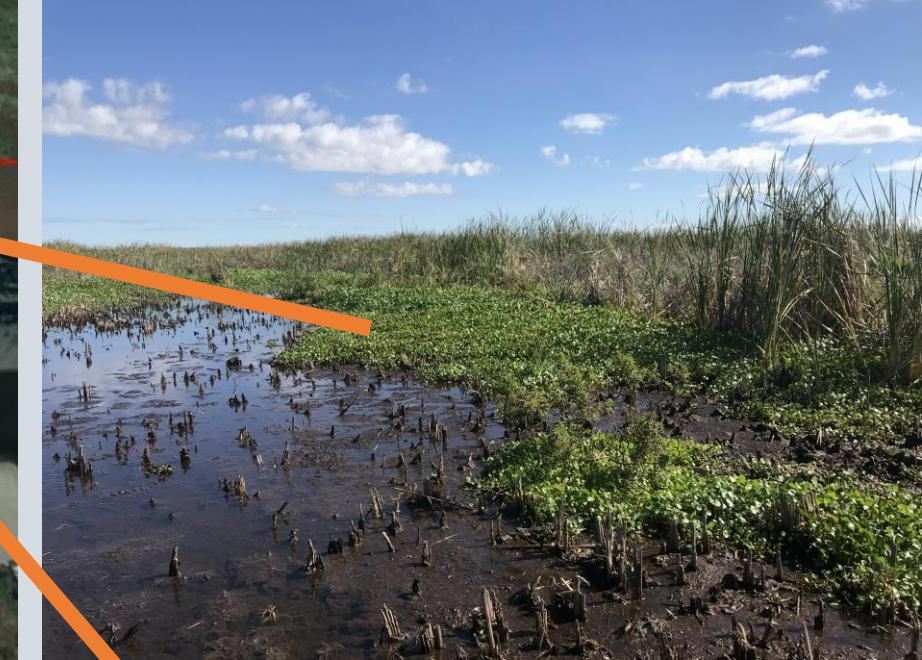
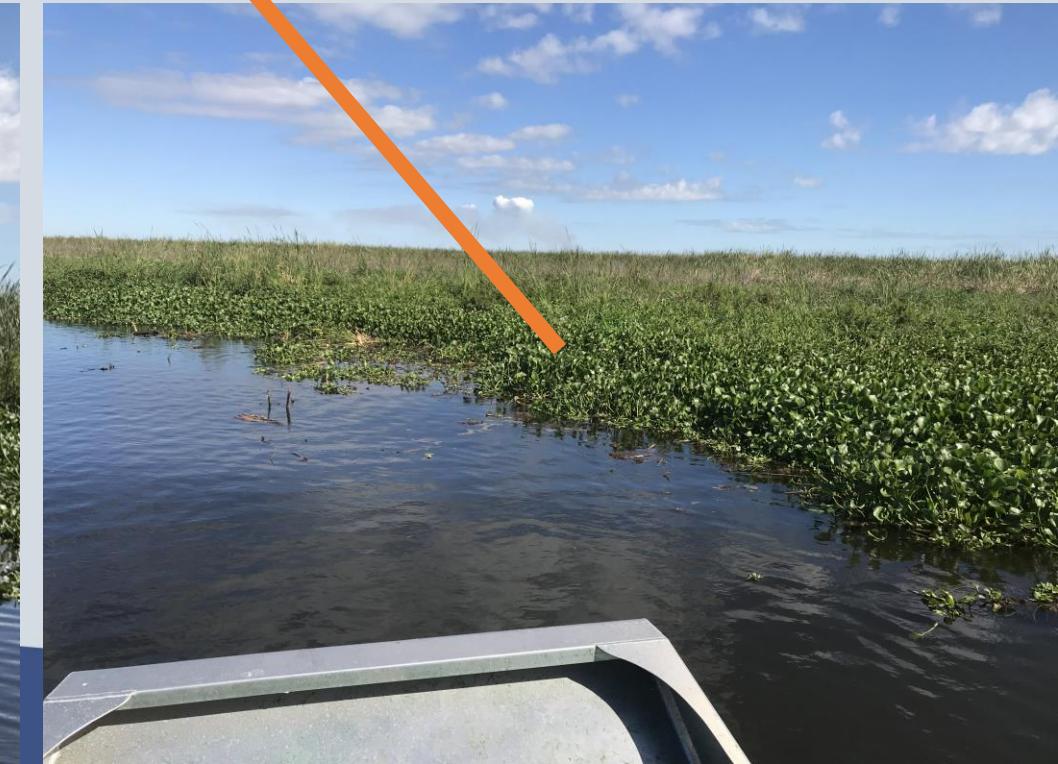
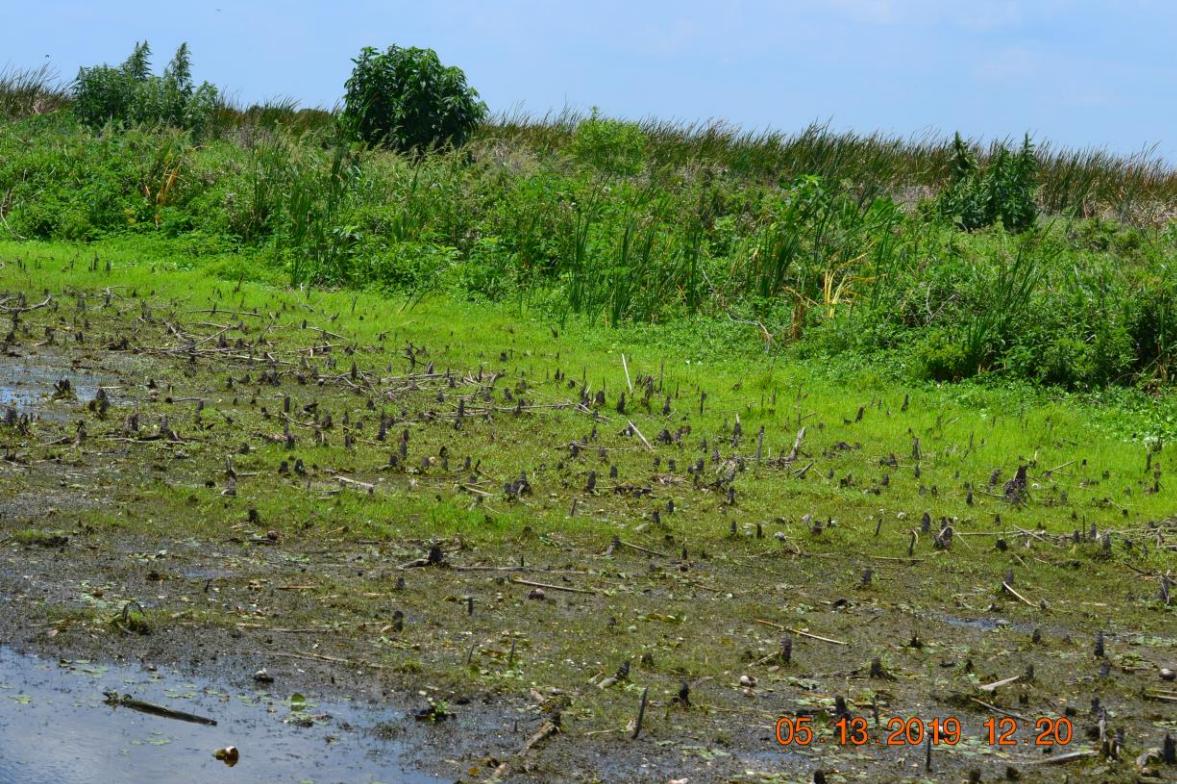
Top Left: Mud having been uncovered and exposed has allowed native grasses to germinate. Bottom Right: Arrows indicate where Water Hyacinth mats cover recently exposed mud where native grasses will not be able to germinate.

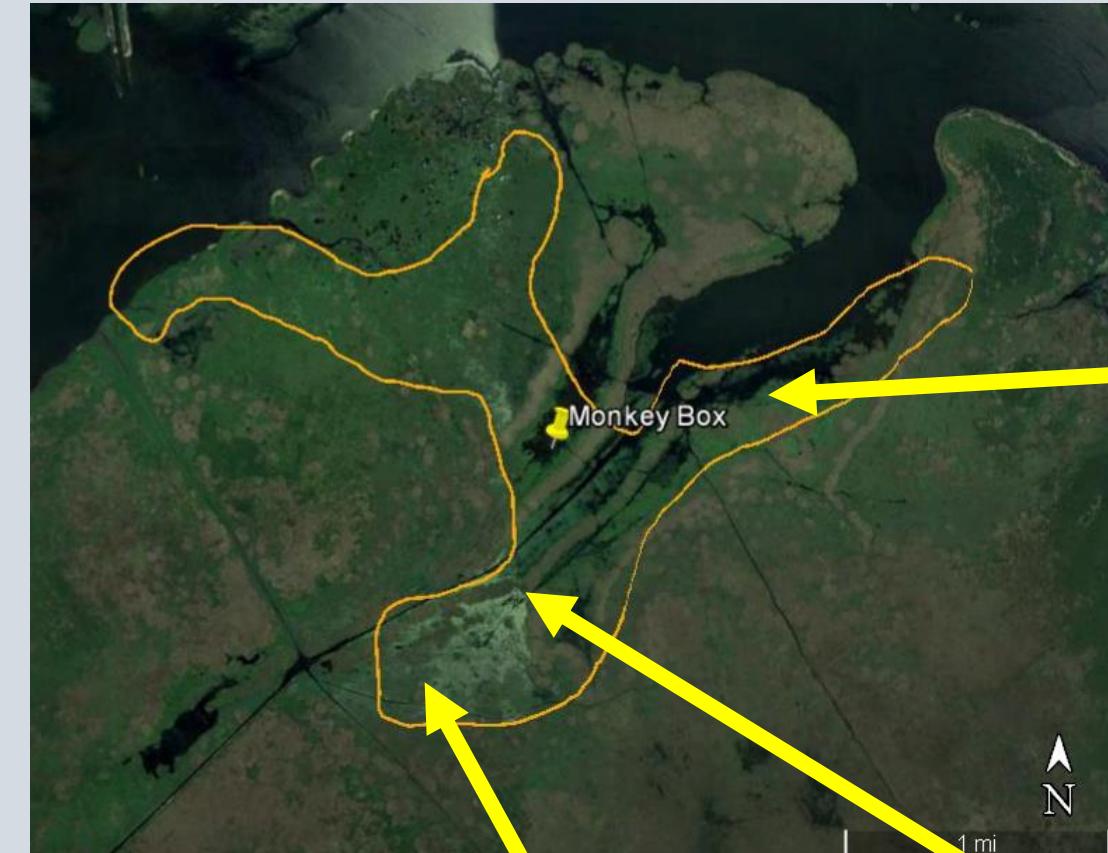
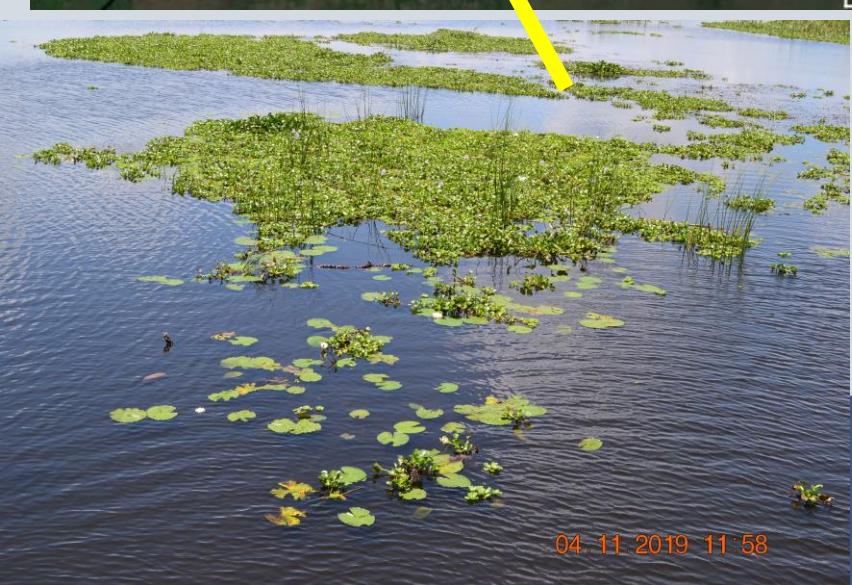
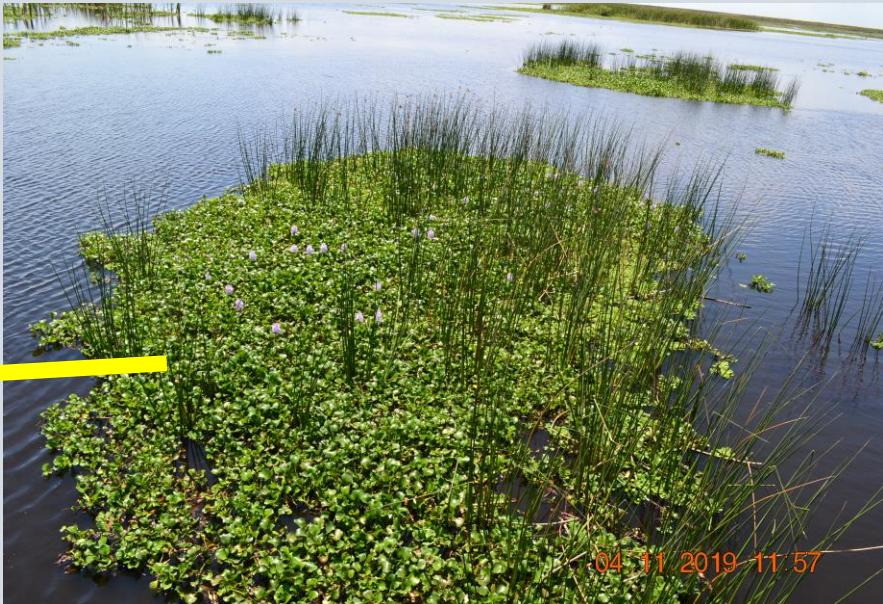
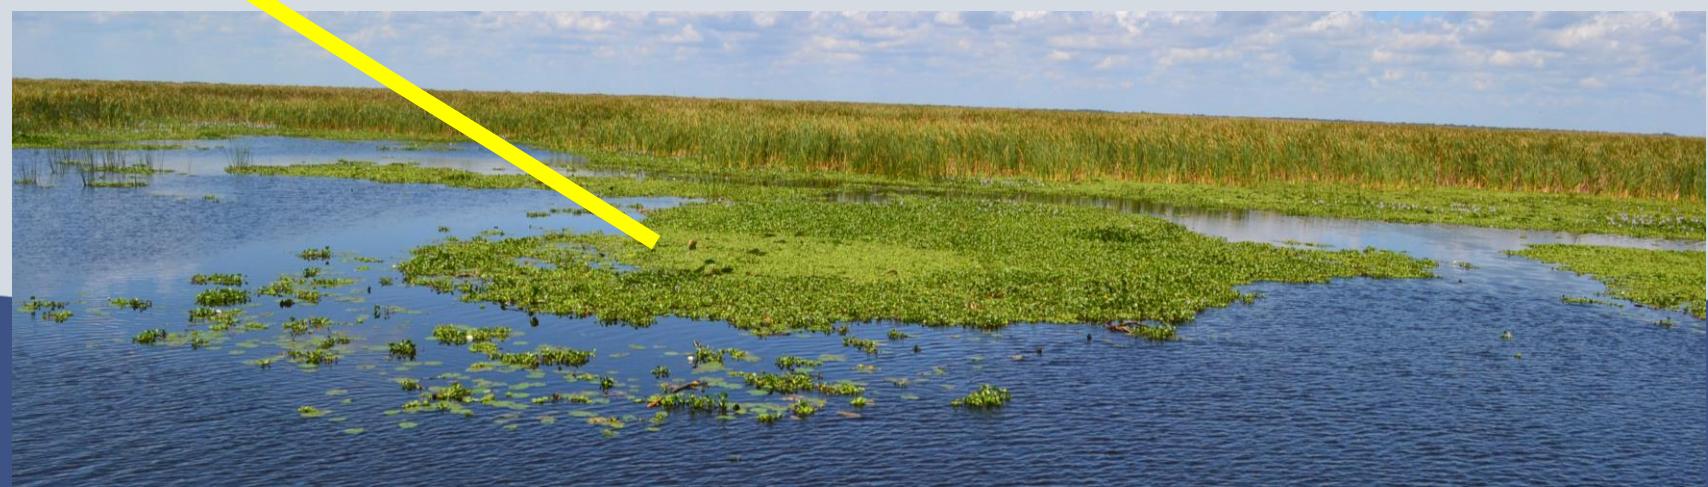
Top Right: Hyacinth choking out native Bulrush and shading out new growth. Bottom Left: Hyacinth forming mats and filling in around Bulrush. Bottom Right: Hyacinth and Lettuce forming mats, pushing into Cattail and Bulrush as well as shading both emergent and submerged vegetation during low water period. This time of year is most conducive to growth of these desirable natives which is being effected.

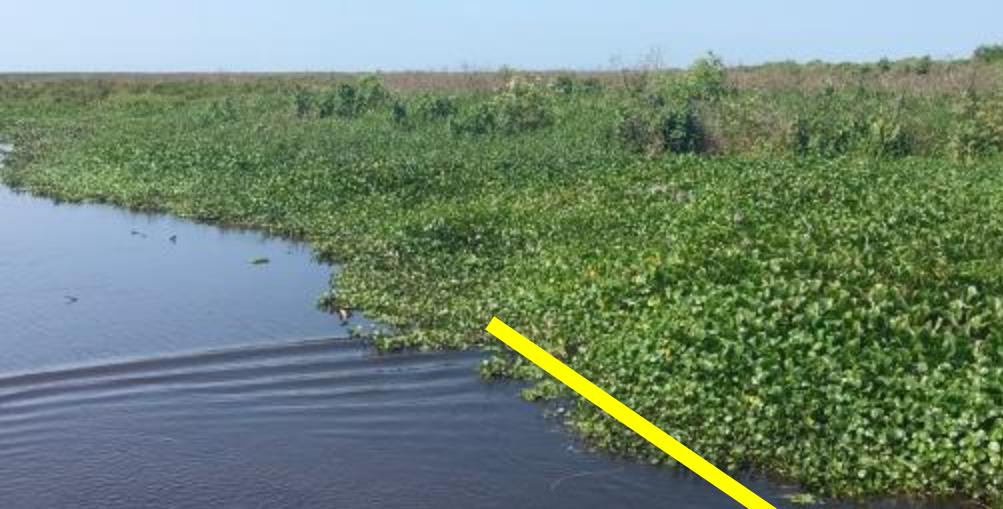
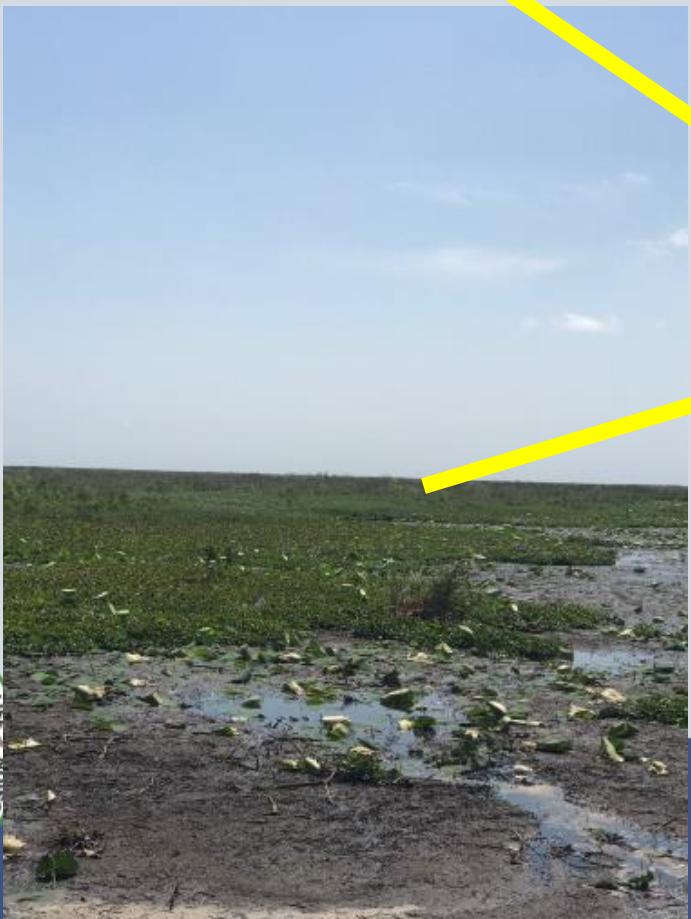
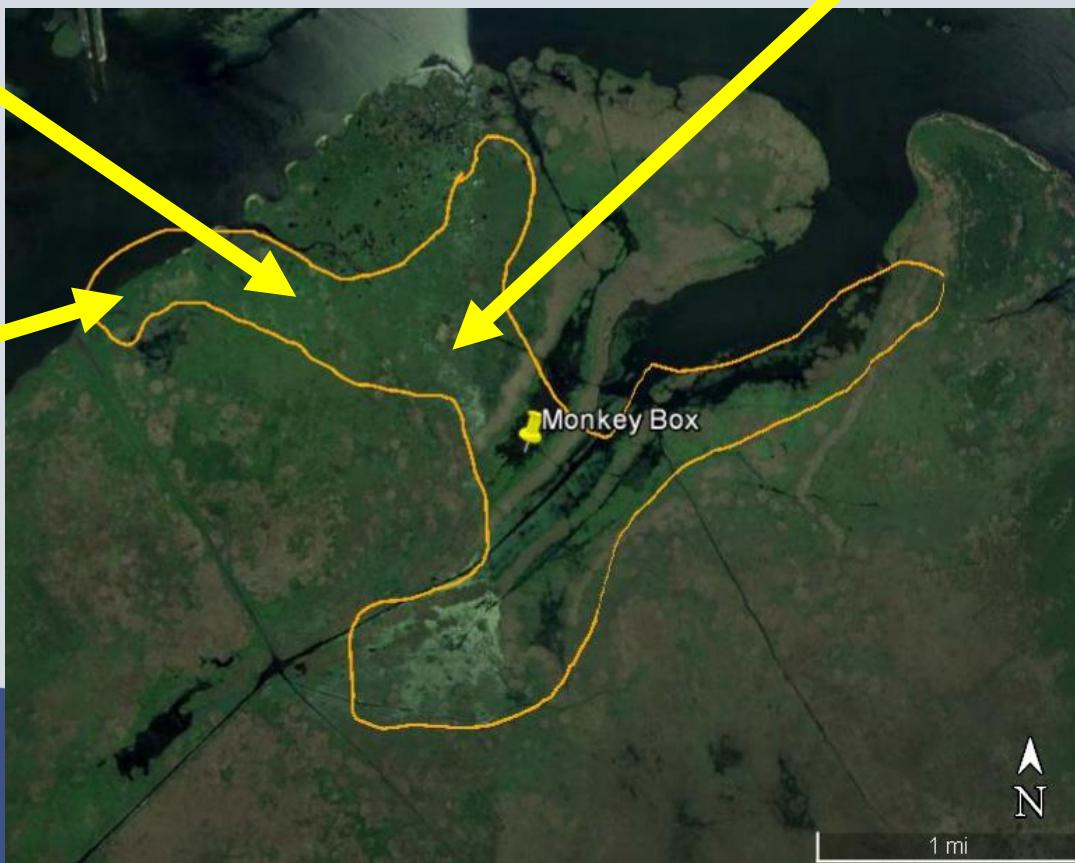
Top left: Shorelines in the area have 2-5 meter band of Hyacinth. Top Right: Mix of Hyacinth and Lettuce forming mat along the vegetation line not allowing native growth. Bottom Left: Due to falling water levels, treating the area may become increasingly difficult

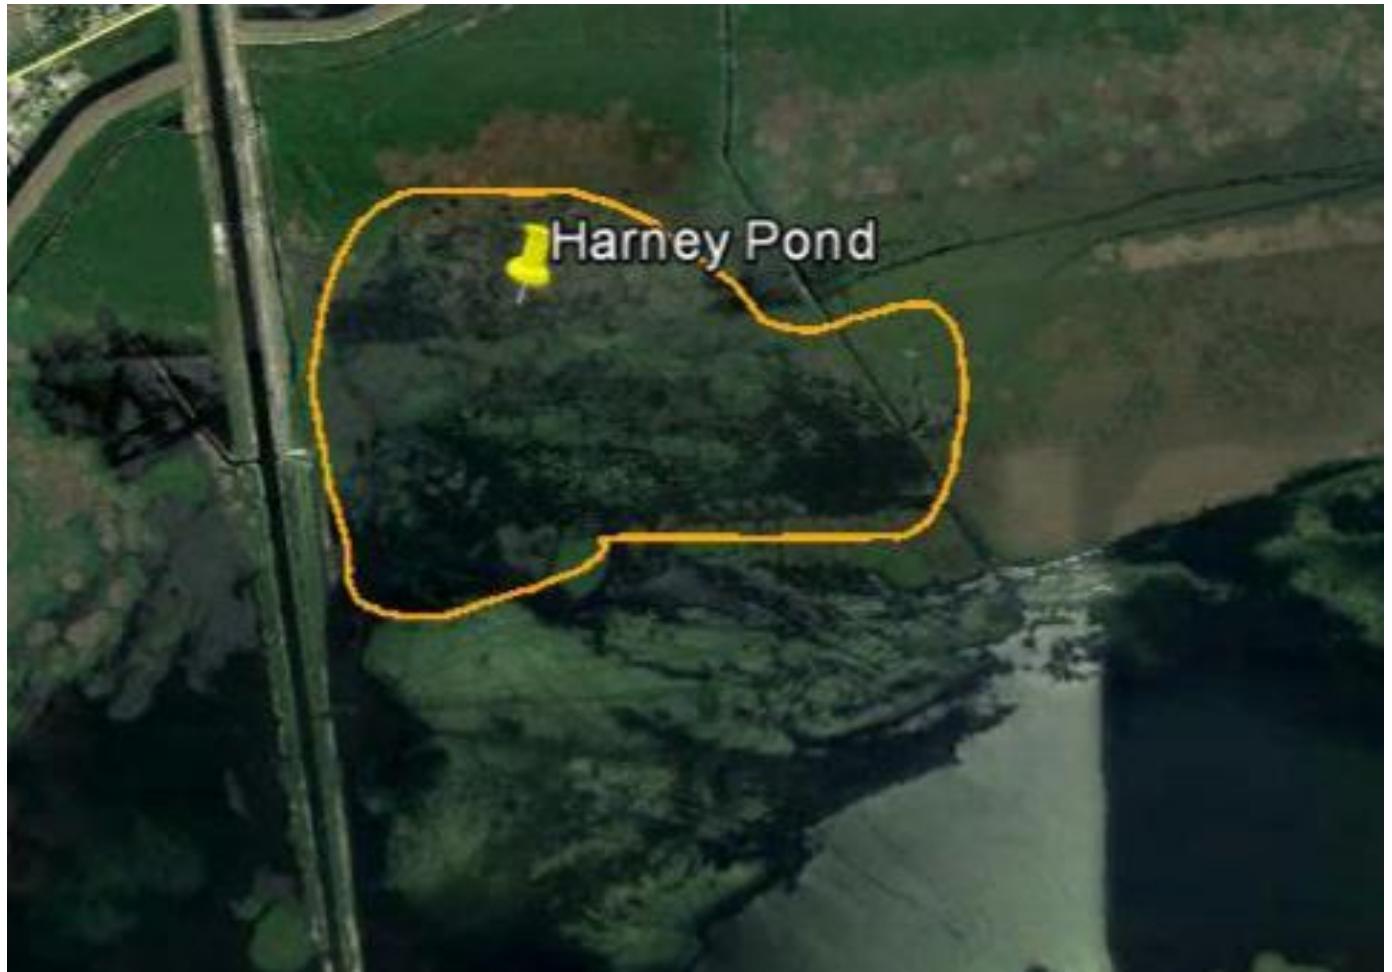
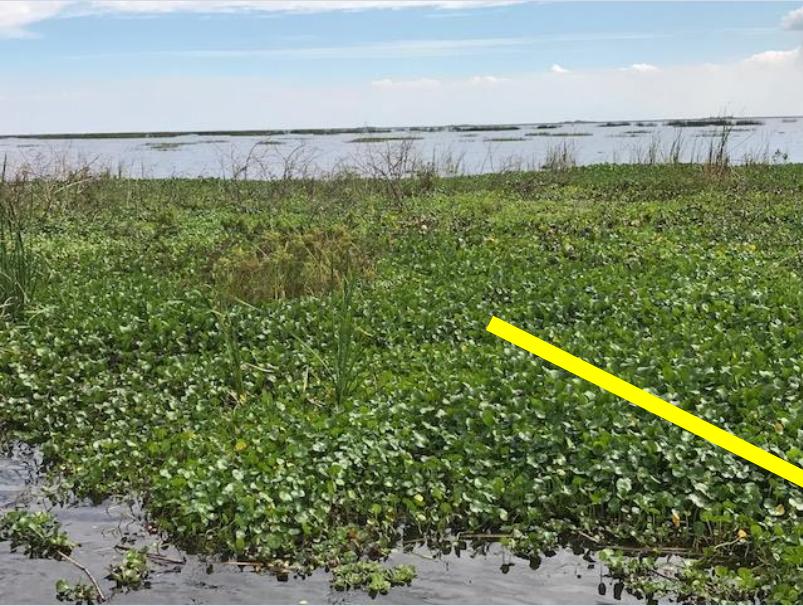
Harney Pond

Top left: Hyacinth mat forming around Cattail and other natives. Bottom photos: Hyacinth smothering native grasses

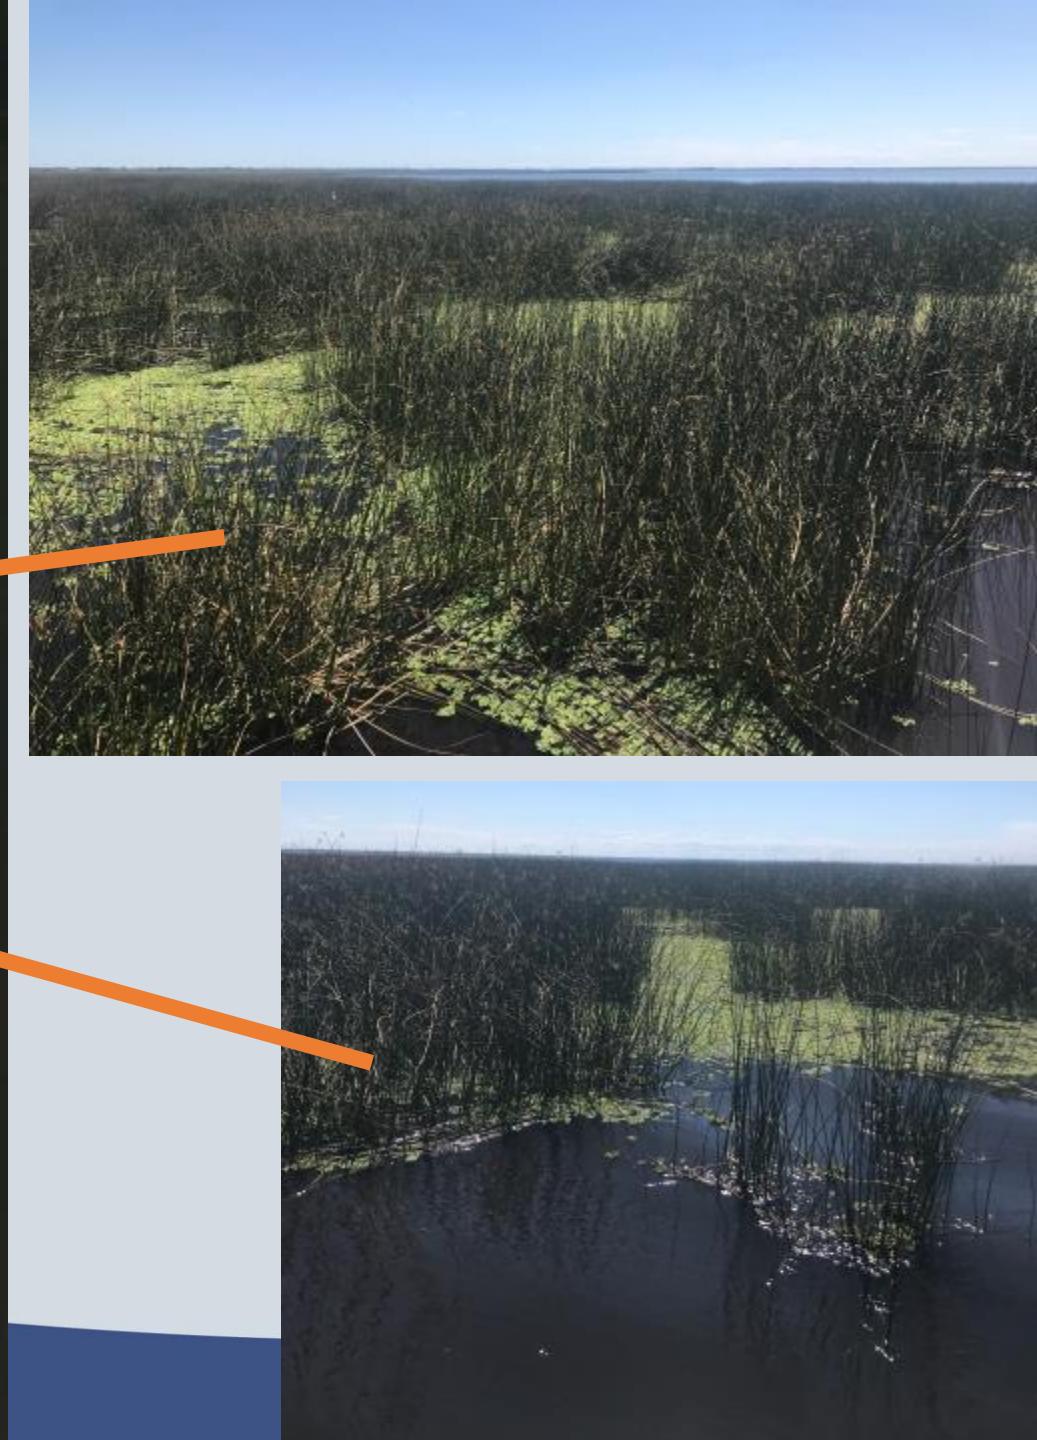
Top left: Hyacinth Pushing over bulrush. Top center: large mat of hyacinth. Bottom Right: 45 inch tall Hyacinth pulled from top left photo site

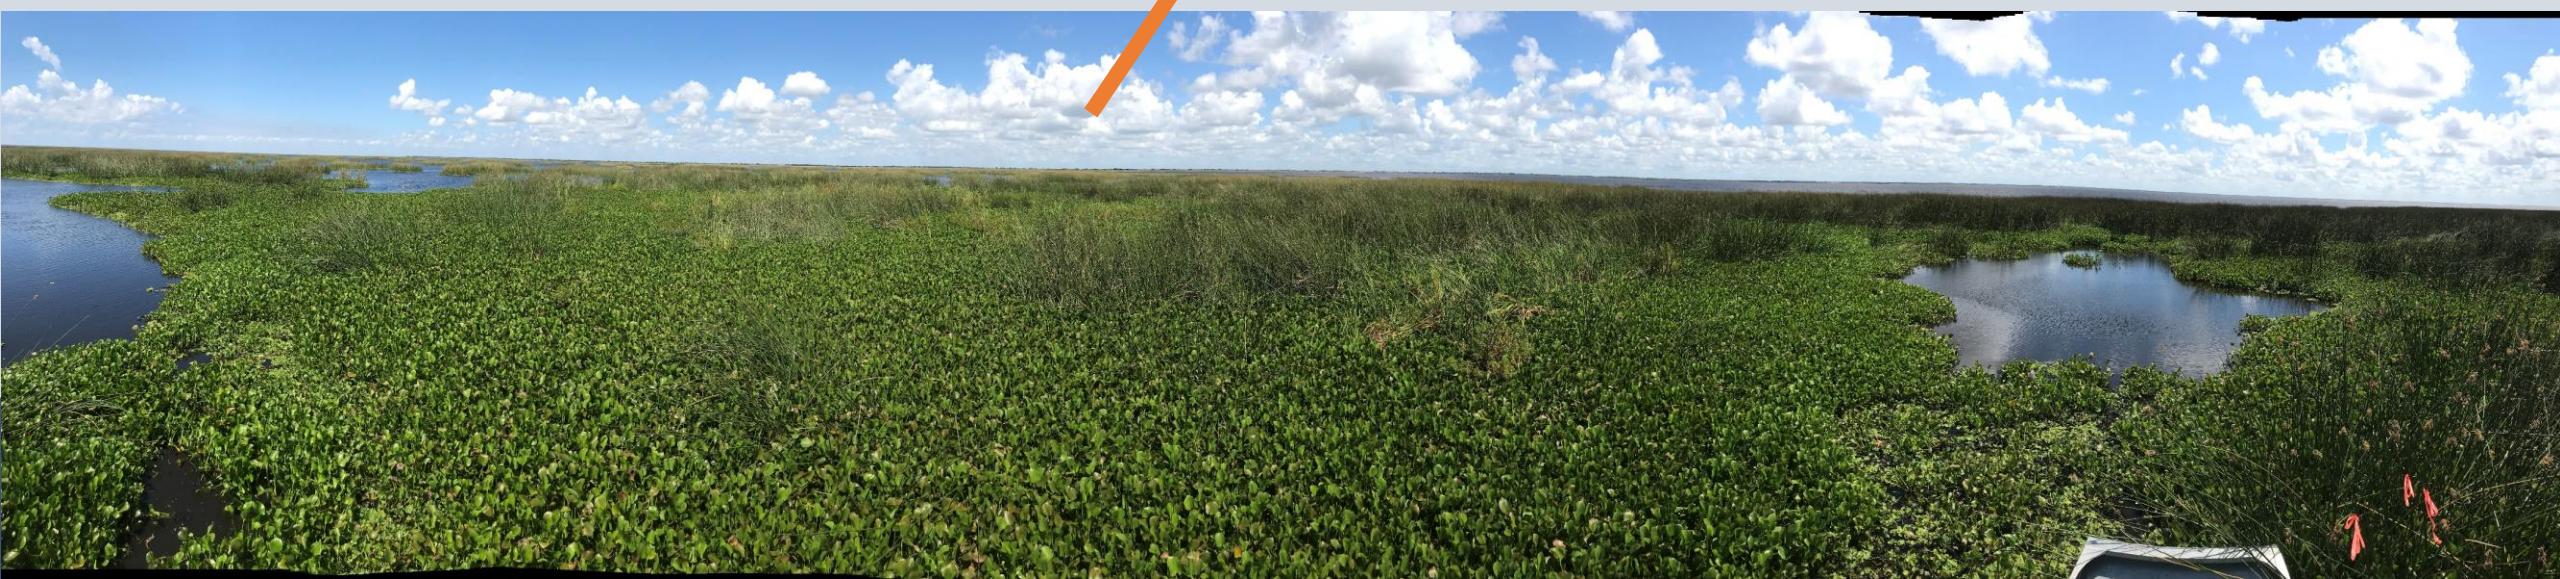
Photo point panorama photo showing the Water Hyacinth growth in the area which is severely impacting natives. Photo point will be used for post treatment assessments.

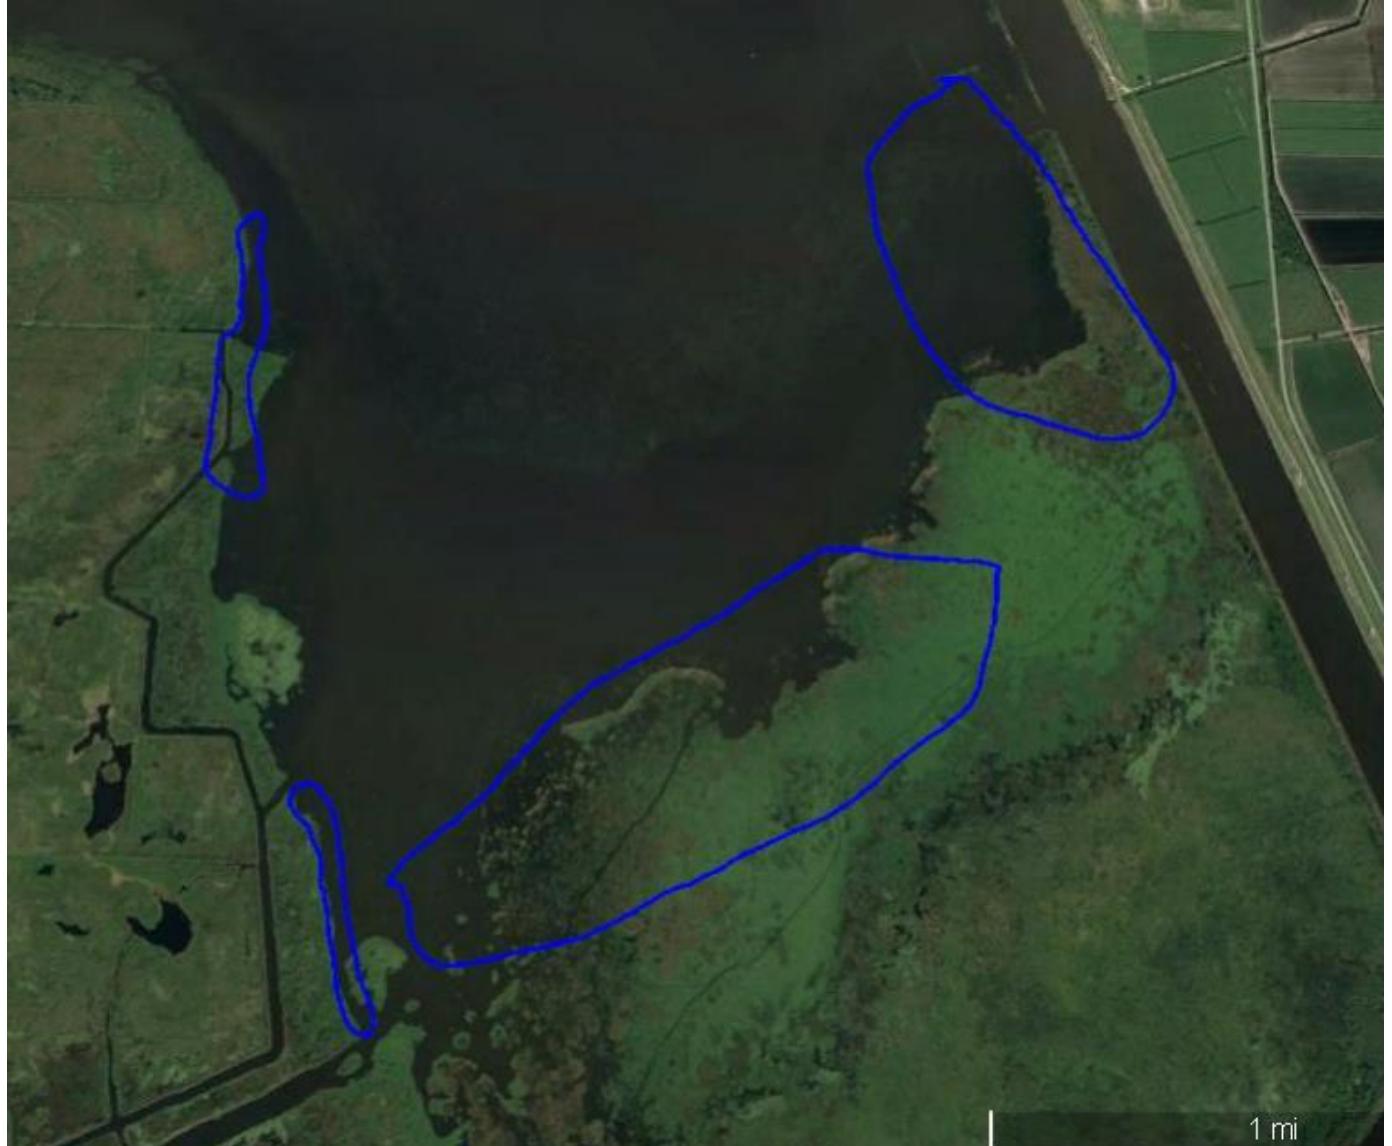
# Pelican Bay

Area infested with Water  
Hyacinth and Water Lettuce.

90 acres of Lettuce

200 acres of Hyacinth

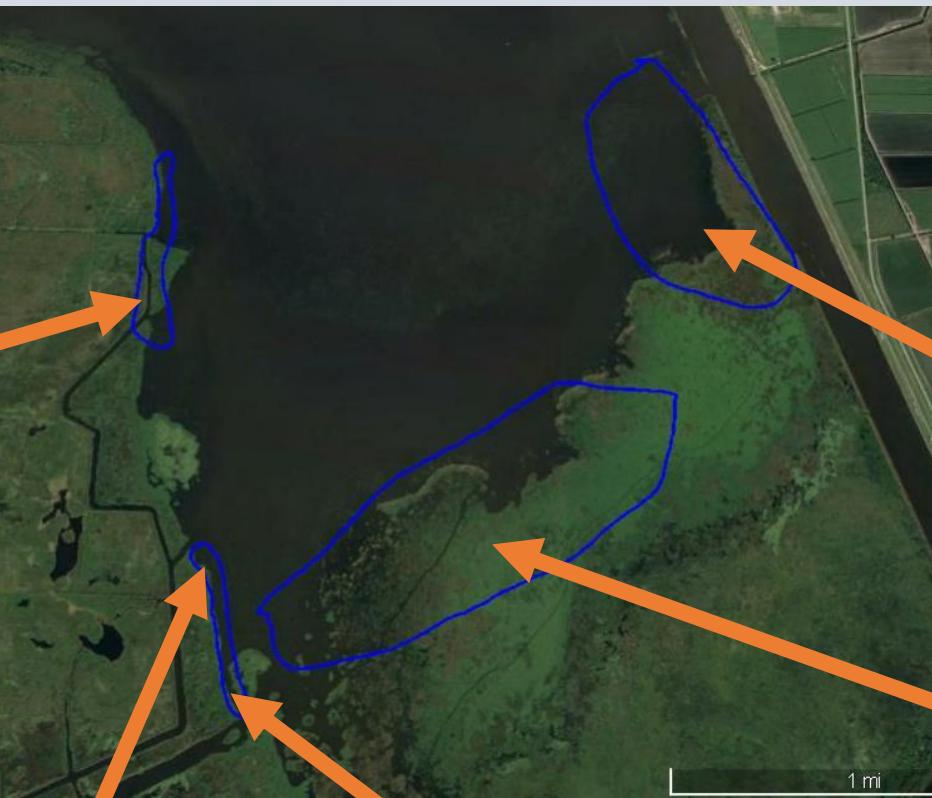
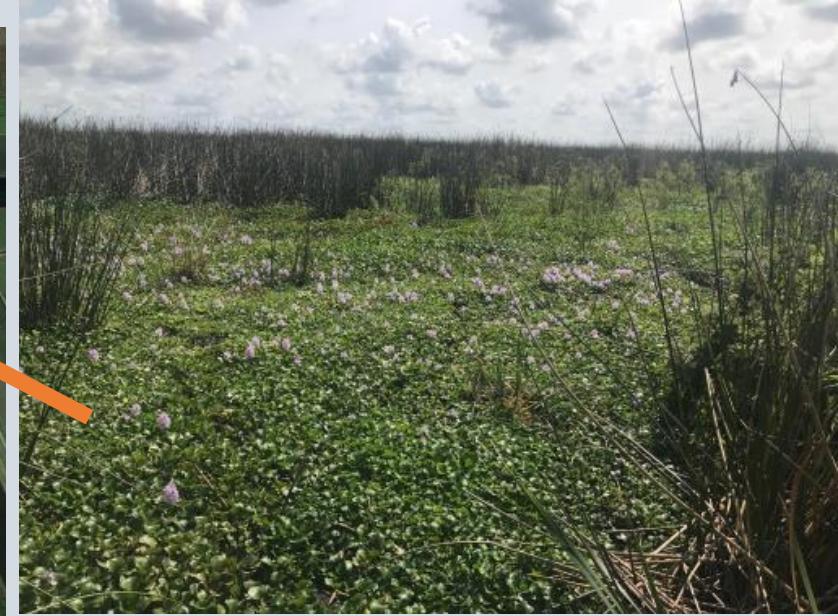
Pelican Bay  
Photos from 4-1-19 helicopter survey
