# Current Lake Okeechobee Floating Plant Treatments: May 2019

The photos and maps below illustrate treatment locations of Water Hyacinth and Water Lettuce within Lake Okeechobee. There is an increase in native vegetation growth due to low water levels. Floating plants can shade out, smother and displace new growth. Treatment is necessary to limit ecological damage to diverse native plant communities.

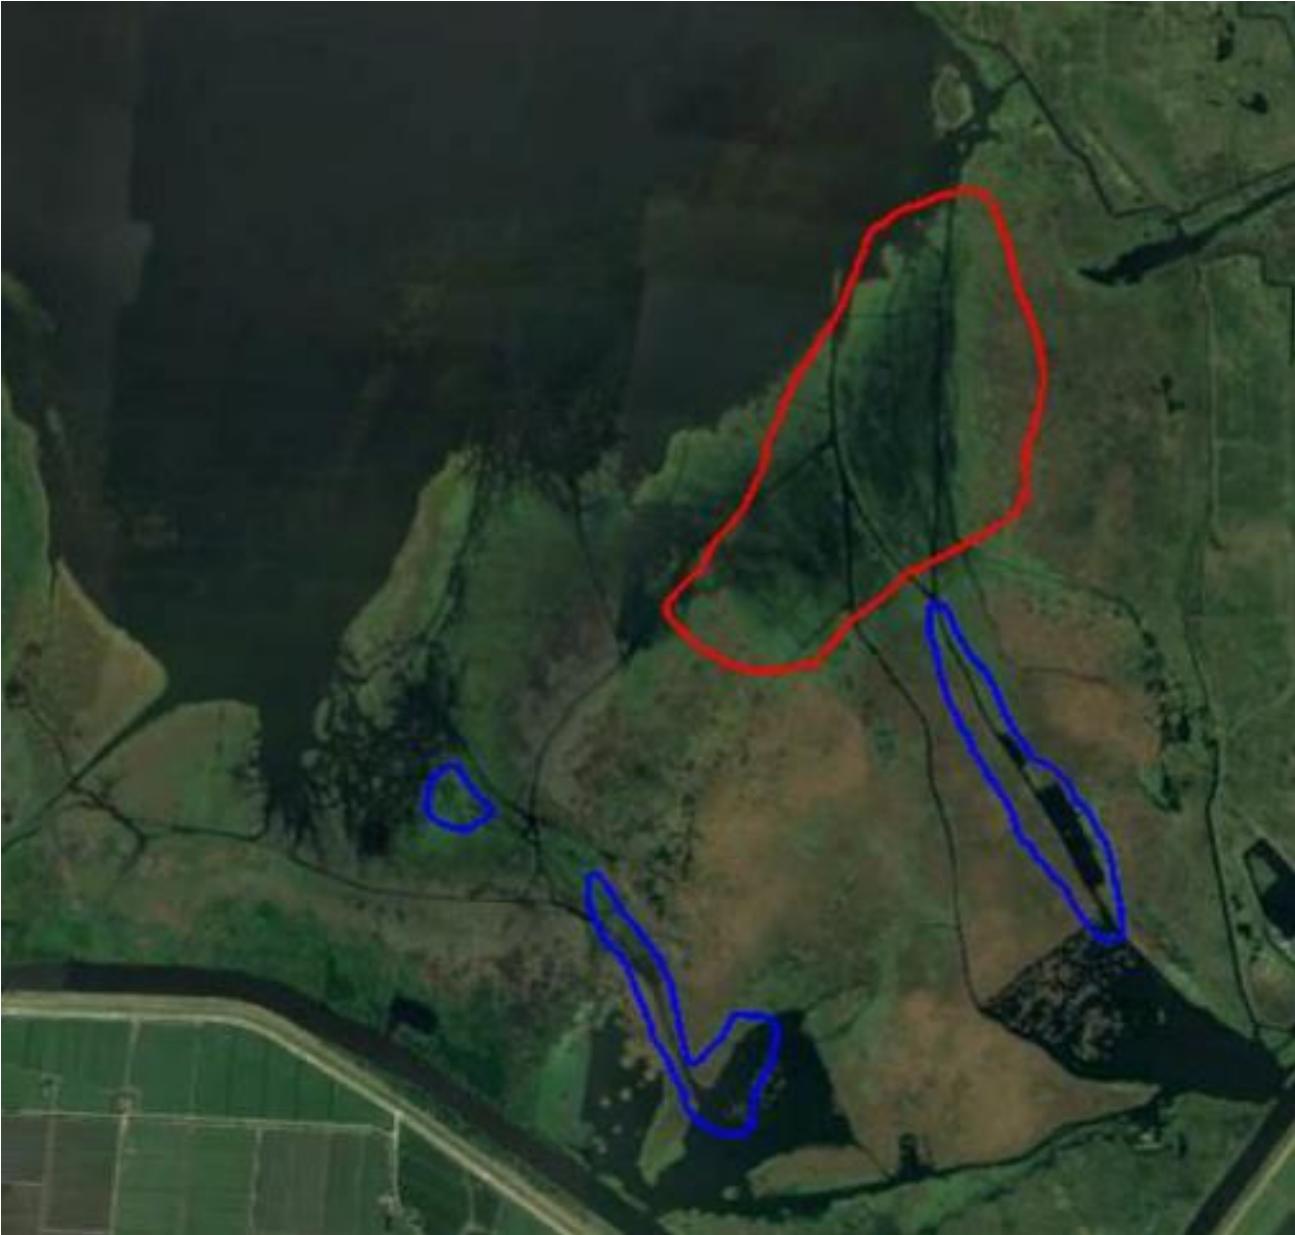
# Halifax Banks Treatment Plan

Area infested with Water  
Hyacinth and Water Lettuce.

90 acres of Lettuce

120 acres of Hyacinth

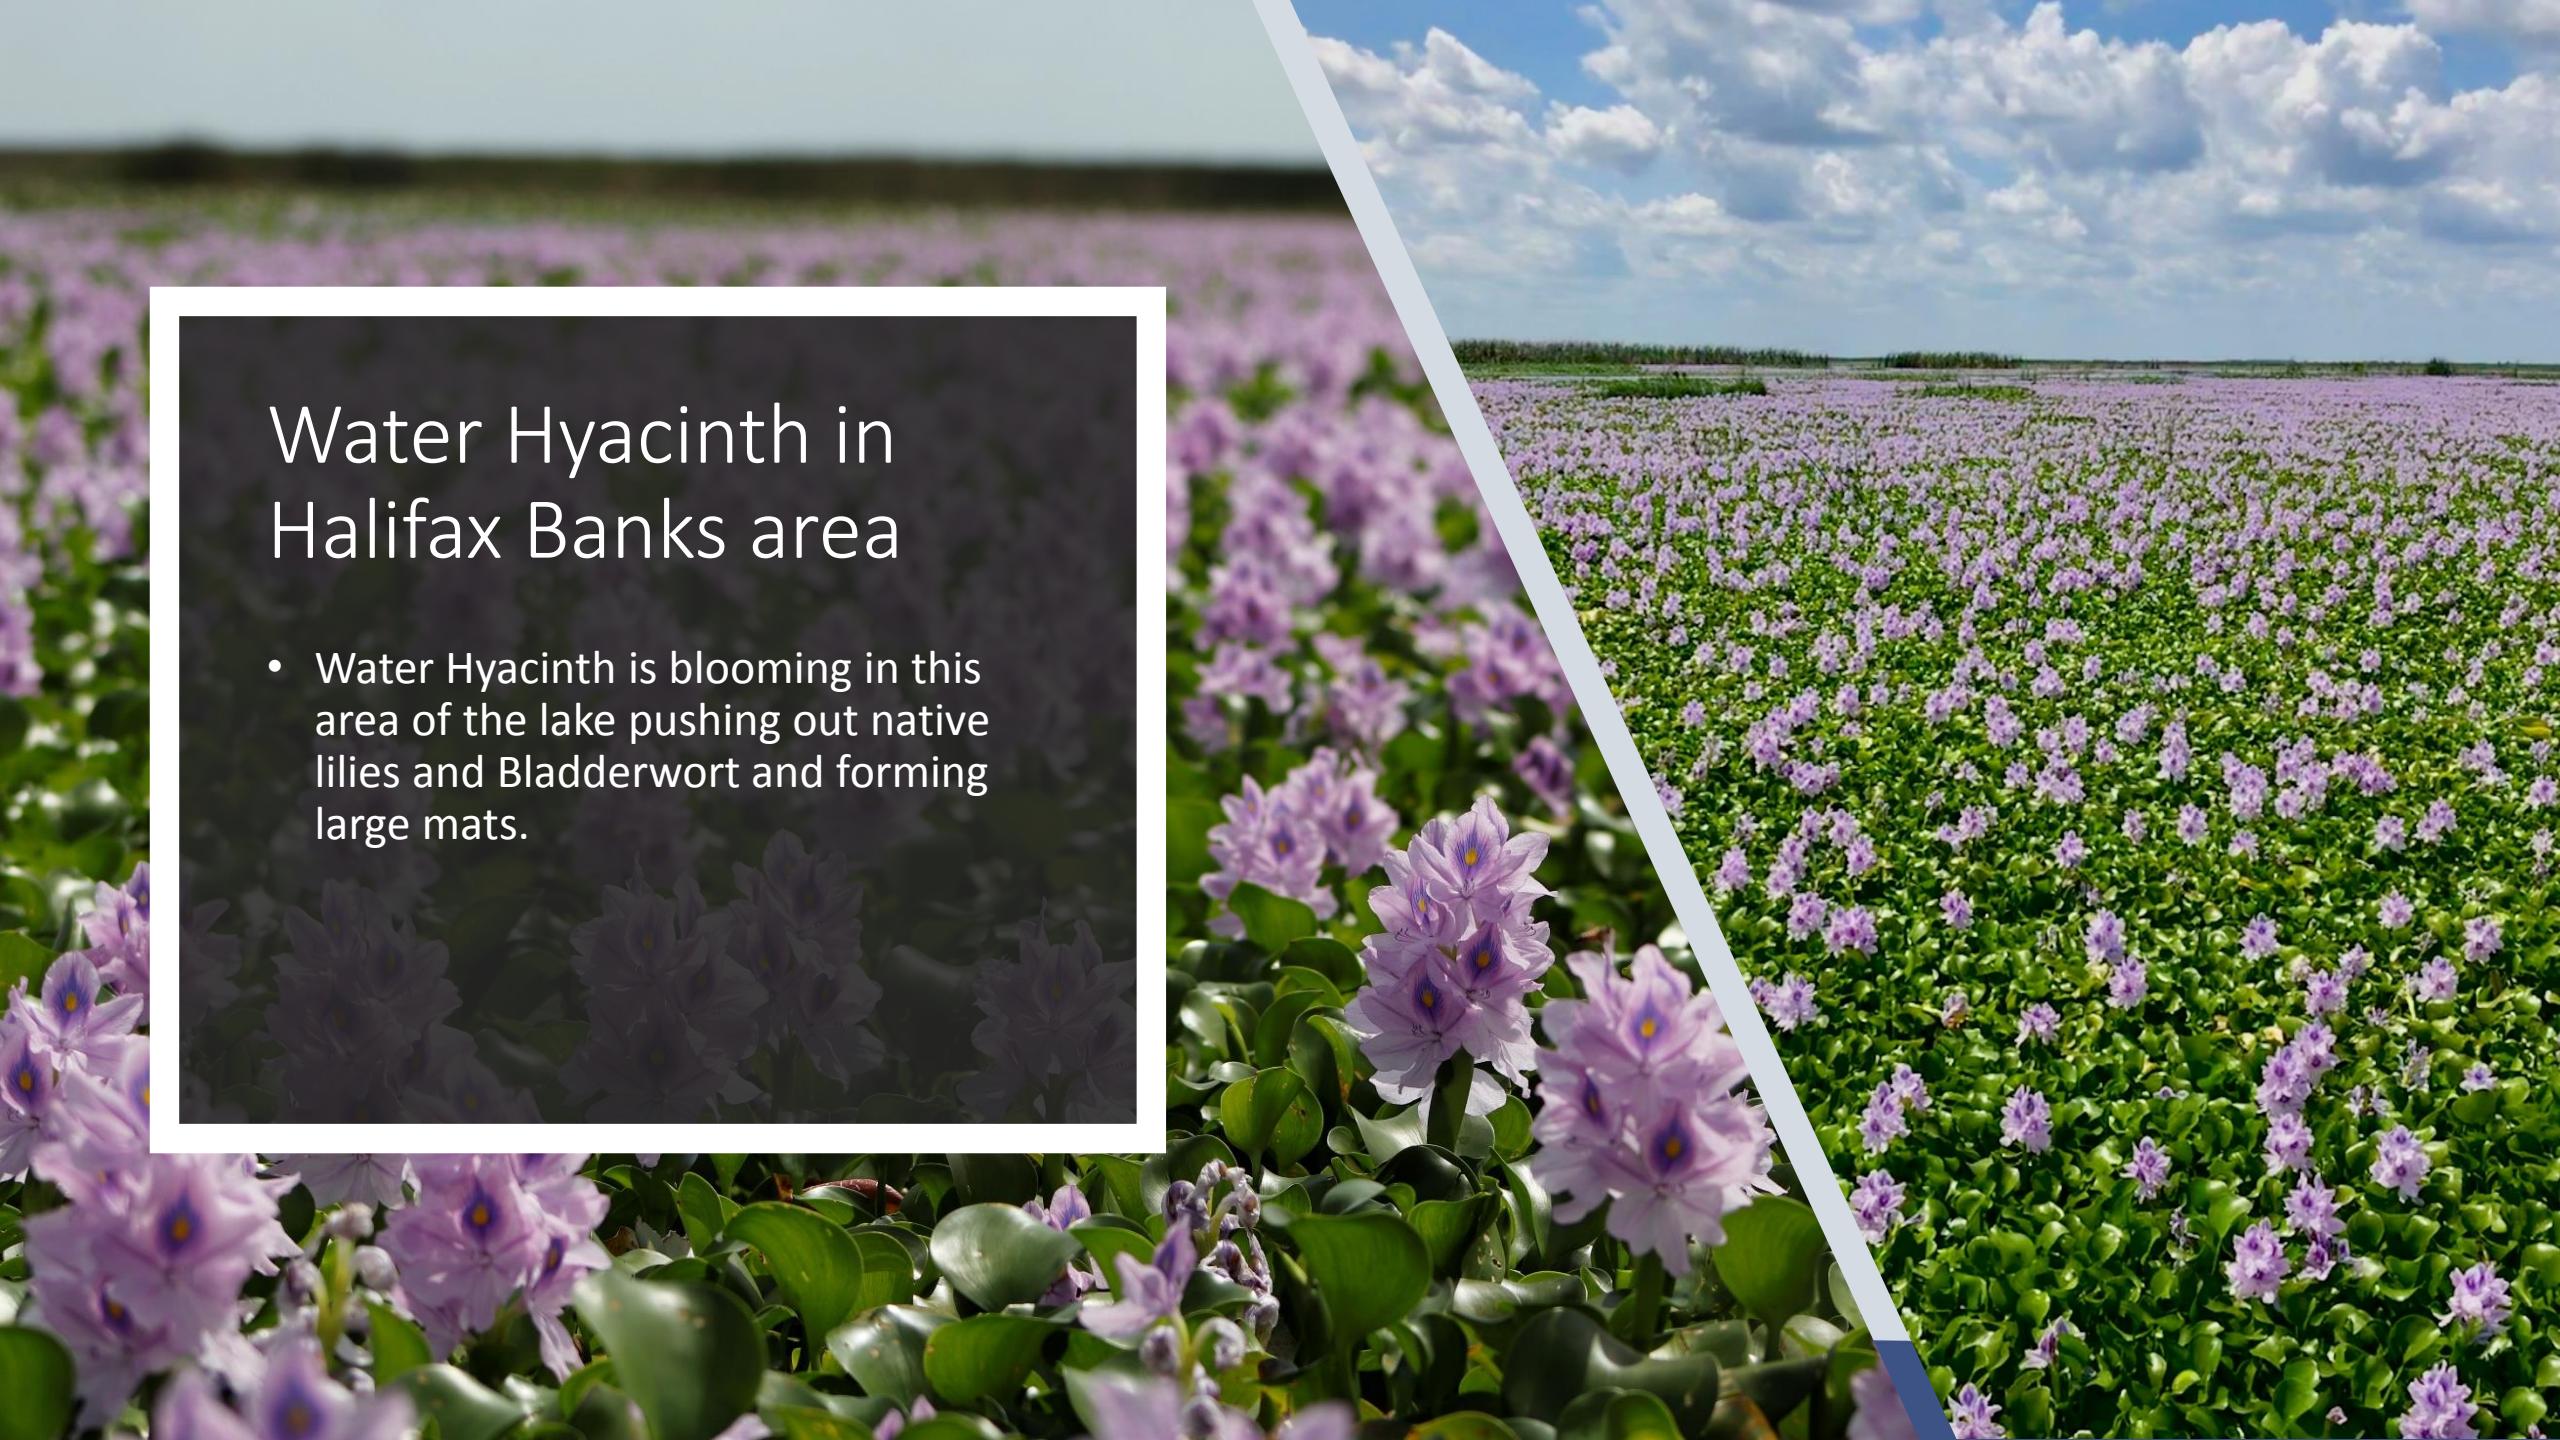
- Water Hyacinth is blooming in this area of the lake pushing out native lilies and Bladderwort and forming large mats.

Aerial Photo points: Left: 2/14/19 Middle: 4/1/19 Right: 4/17/19

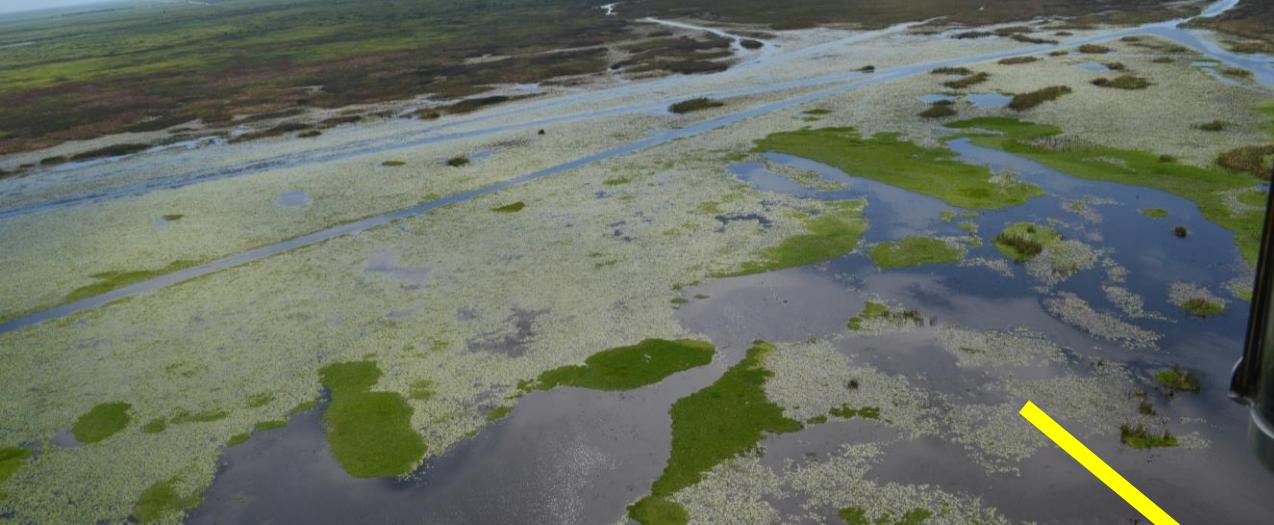
Halifax Banks: Red polygon is potential mechanical harvesting site, 120+ acres of Hyacinth and 90+ acres of Lettuce.
