Backing Incidents – Incident Review

The purpose of this incident review packet is to learn from recent past incidents and review MnDOT policies and best practices to prevent future occurrences.

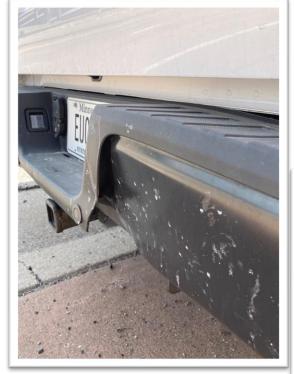
June Incidents (1 of 4)

"Backing up on shoulder to get to a hand hole. Didn't check to see if path was clear."

Did not follow Safety Policy. Failed to use backup camera and alarm and did not take the time to check if the area behind the vehicle was clear.

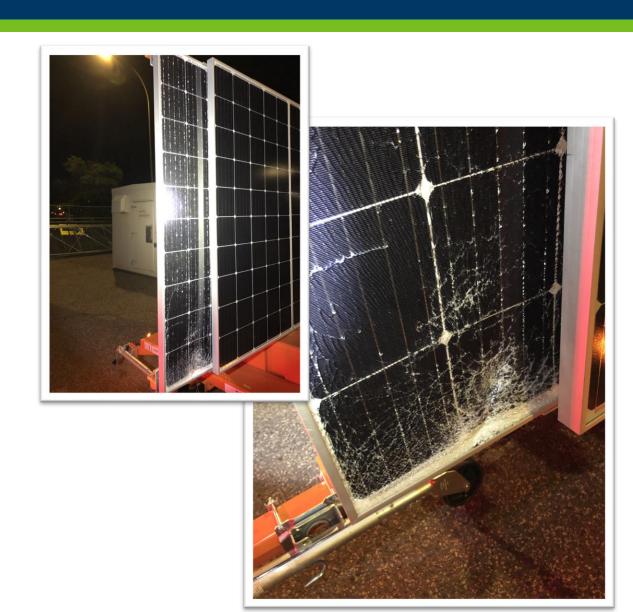
June Incidents (3 of 4)

"Backed up the light tower in yard to park.
Turned a bit sharp while backing, the back
of the one-ton metal latch made contact with
the light tower panel, shattering the corner
panel."

Did not follow Safety Policy. Failed to use a spotter. In absence of a spotter, failed to stop and re-check the path of travel and visually rechecking the area to the rear of the equipment.

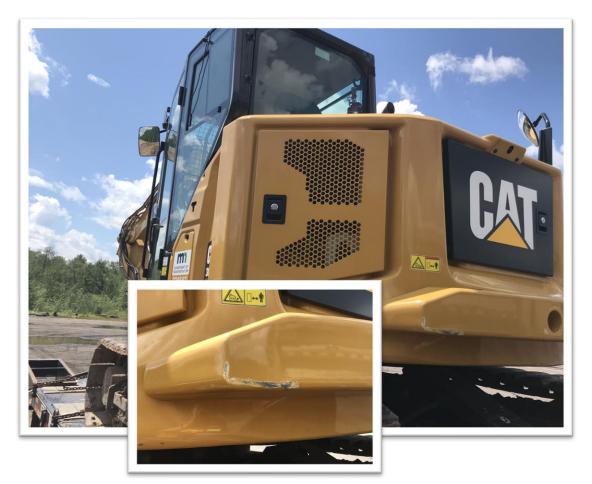
July Incidents (2 of 5)

"We were working on a vertical pipe in the median. After repairing the culvert employee was going to drive the small Cat 908 loader back. As they were about to leave, instead of steering to the left and heading east, they backed up and without looking behind, they backed into the Cat Excavator. XX was spotting employee so they could turn around safely, and employee had no reason to back up to turn the loader around. XX yelled and pointed for employee to stop. They slowed a little, then hit the throttle and then contacted the Cat Excavator. The Excavator was not running and was unoccupied at the time of the incident. The excavator was parked on the shoulder waiting to be loaded back onto the trailer. The damage is to the paint only and there was no damage to the lights."

Did not follow Safety Policy. Failed to look before backing. Failed to follow spotter's instructions.

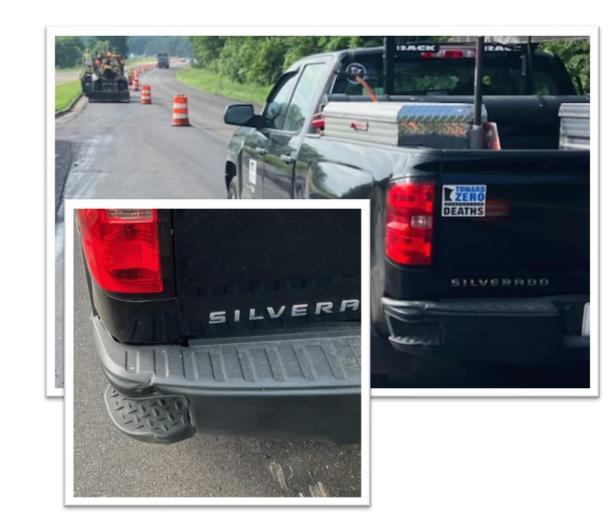
July Incidents (3 of 5)

"Was talking to paving foreman. Got back into truck to move out of tractor's way that was cleaning up. Check my mirrors. Thought roller was backing up so I looked out my passenger side mirror to start backing up to get out of tractor's way and backed into roller."

Did not follow Safety Policy. Failed to walk to the rear of the vehicle and visually check for personnel or obstruction in the planned area of backward travel.
