Background

Interstate Bridge Trunnion Timeline

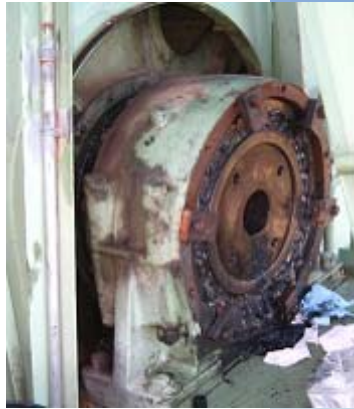
A *trunnion* is the axle of the lift span's pulley.

The 20-inch diameter trunnion and pulley wheel weigh about 21 tons.

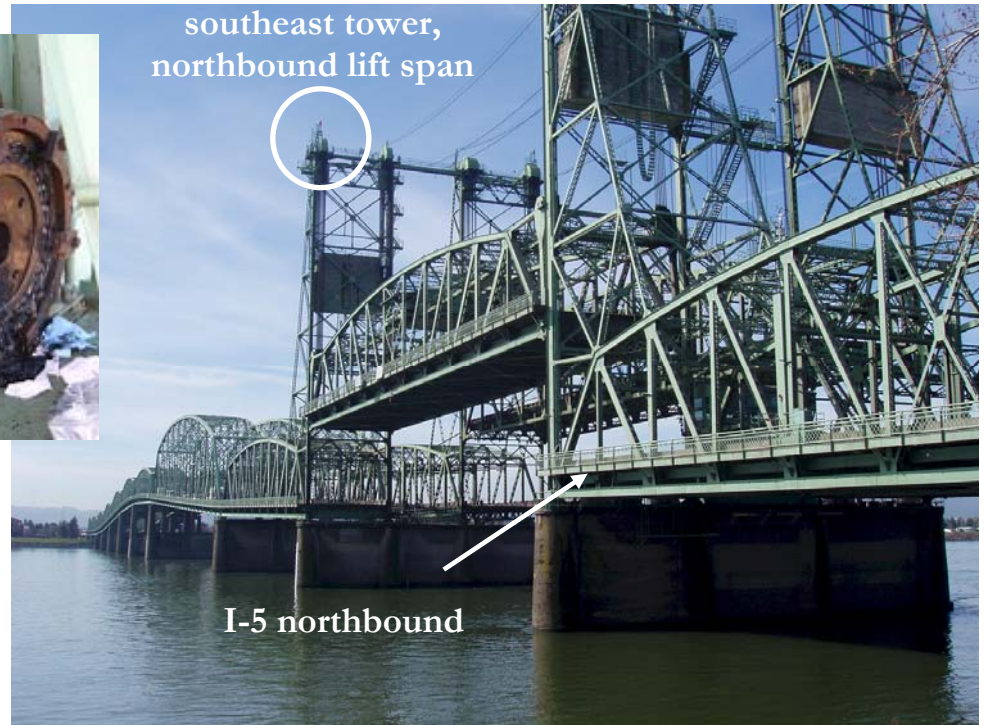
- **1999, 2004, 2011:** Ultrasonic tests performed on the two trunnions on the south tower of northbound bridge
- **2011:** Crack about 1/2-inch deep found in southeast tower trunnion; not visible to the naked eye

- **4/2012:** Dr. Fisher concluded this crack is growing at the predicted rate; he also concluded that the trunnion could stay in service safely until the year **2045**. An OSU expert reviewed and concurred

- **Future:** As an extra margin of safety, ODOT recommends trunnions be left in service until the crack reaches about half the size recommended by Dr. Fisher, which at the current growth rate would be in the year **2026**. ODOT will perform detailed ultrasonic inspections in the summer of 2012, 2013 and 2014
