# Gully treatment with grassed waterways

By Cam McGinnis, Morristown Field Office soil conservationist

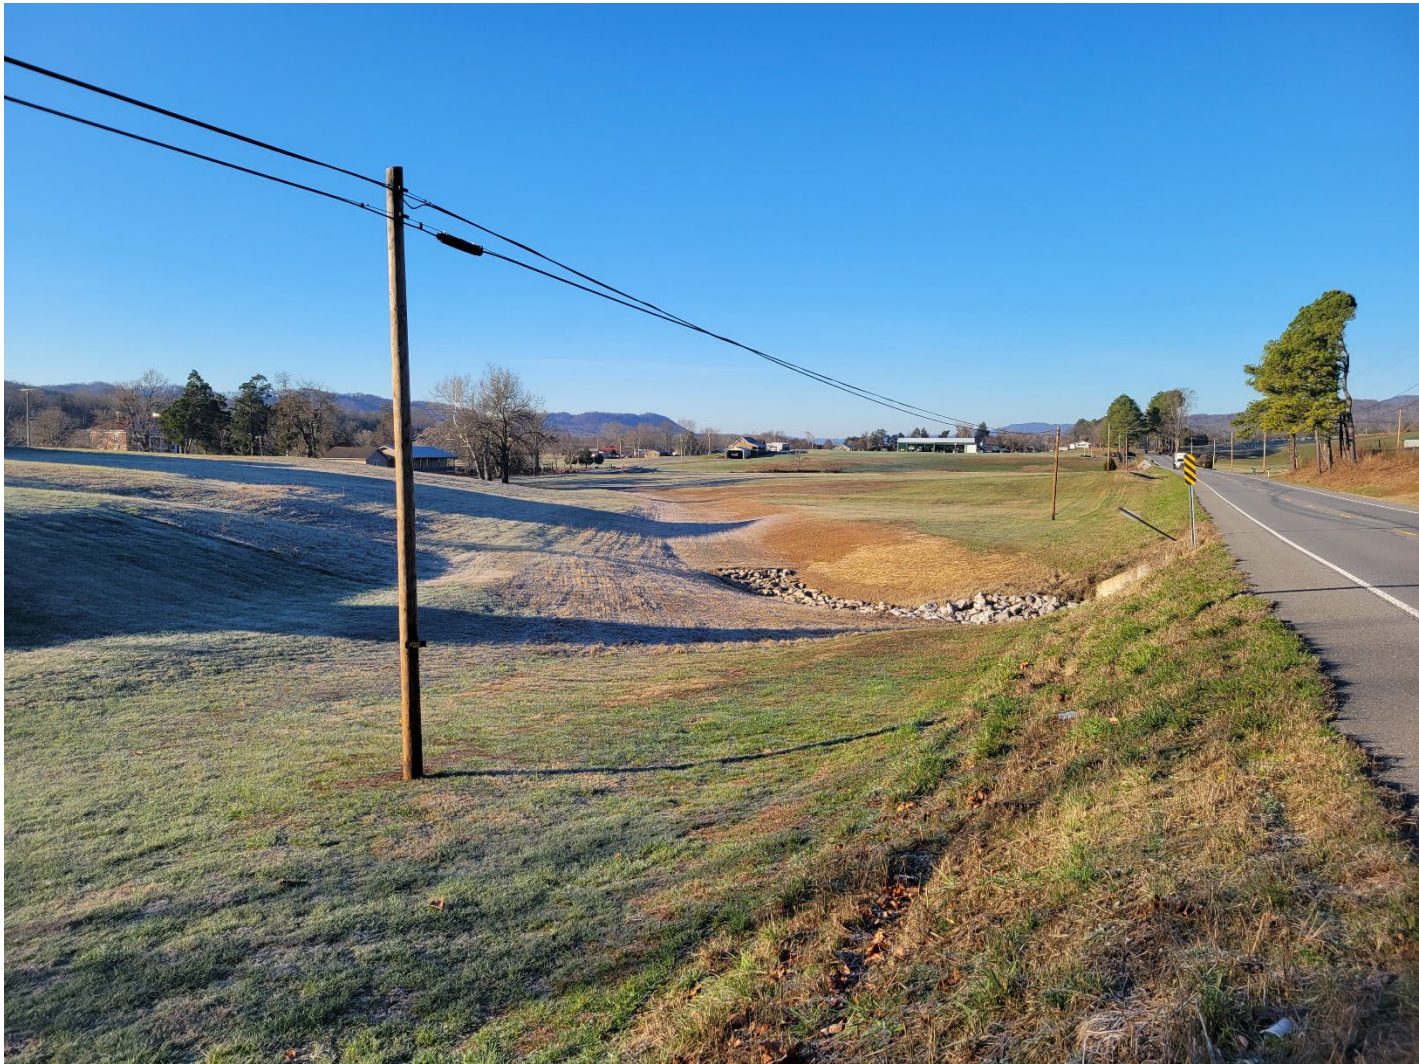
Rutledge, Tennessee, resident David Hixon recently contacted the Morristown Field Office about an increasingly problematic gully that had divided his hayfield. The erosion was caused by stormwater runoff within a localized watershed with little vegetative cover to slow water above Hixon's farm.

After consulting with our area engineering staff, we concluded that a grassed waterway with rock lined waterways at the inlet and outlet of the structure would be the most effective way to address his growing problem. Through the National Water Quality Initiative program, Hixon was able to receive cost-share funding to hire a local contractor to install the practices.

After construction, the entire structure and all the surrounding areas that were disturbed due to construction were reseeded with Brown Top Millet to provide a temporary, fast growing, cover while we waited for optimal seeding dates for perennial grass. As proper seeding dates approached the dry weather improved just enough to give David the opportunity to have Tall Fescue planted as the perennial cover that will provide year-round living

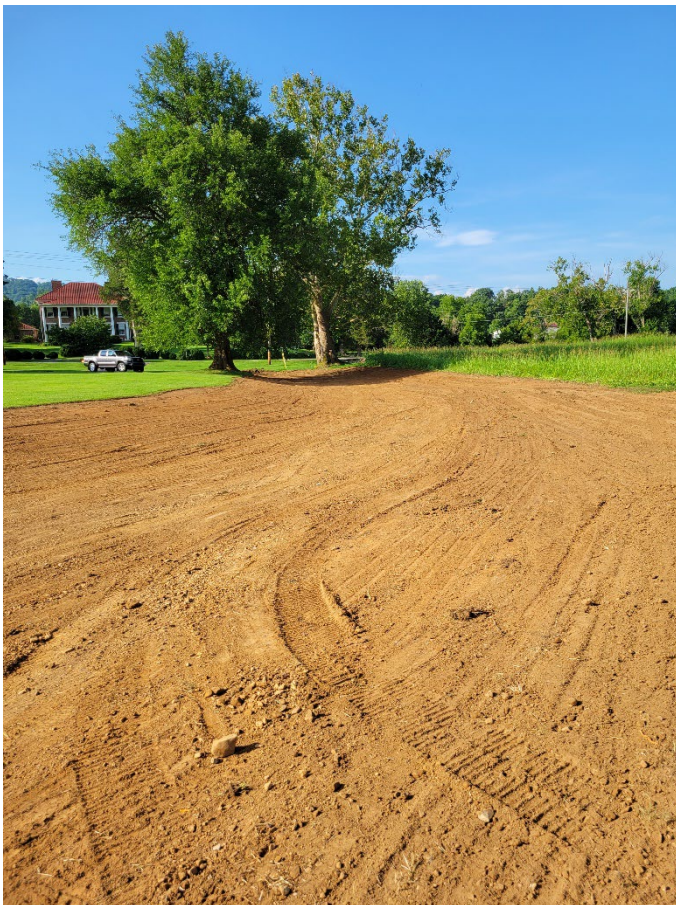
cover to stabilize the site. Hixon says he is very pleased with how the structure turned out and says he is glad it was addressed before things got worse.
