Island County Fish Passage Barrier Inventory: Priority Area 2

Water Resource Inventory Area 6

Final Report December 2022

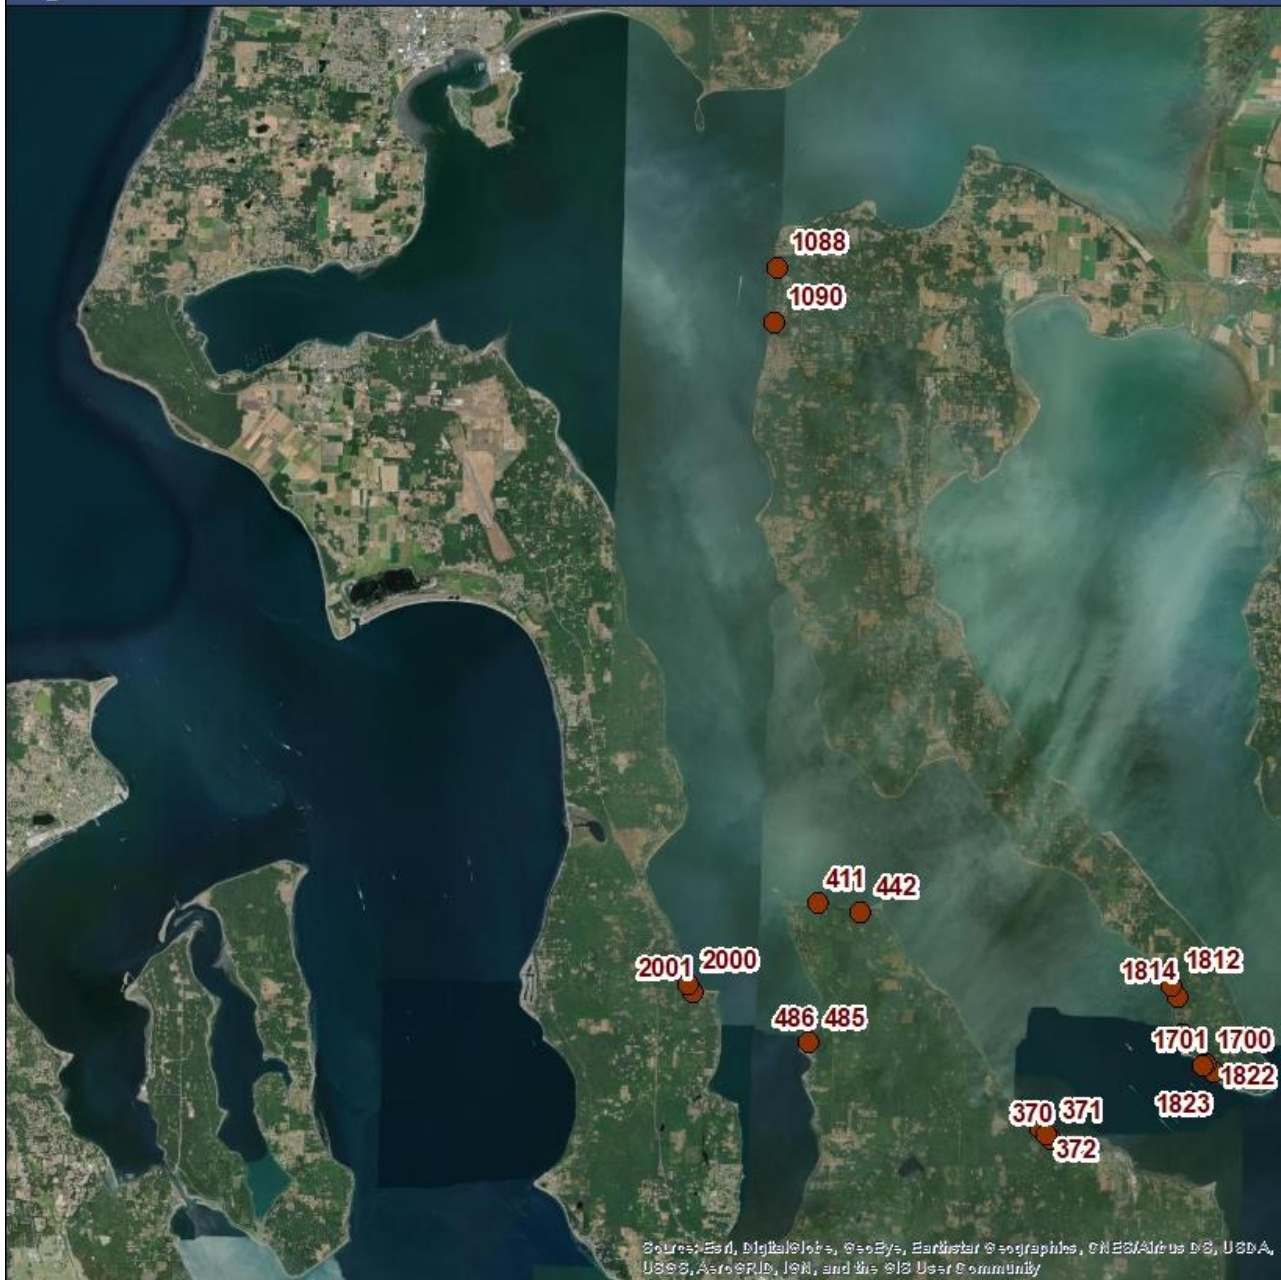
Figure 2: Map of county-owned stream crossings that were excluded from survey list due to a stream gradient >20% where the stream entered Puget Sound

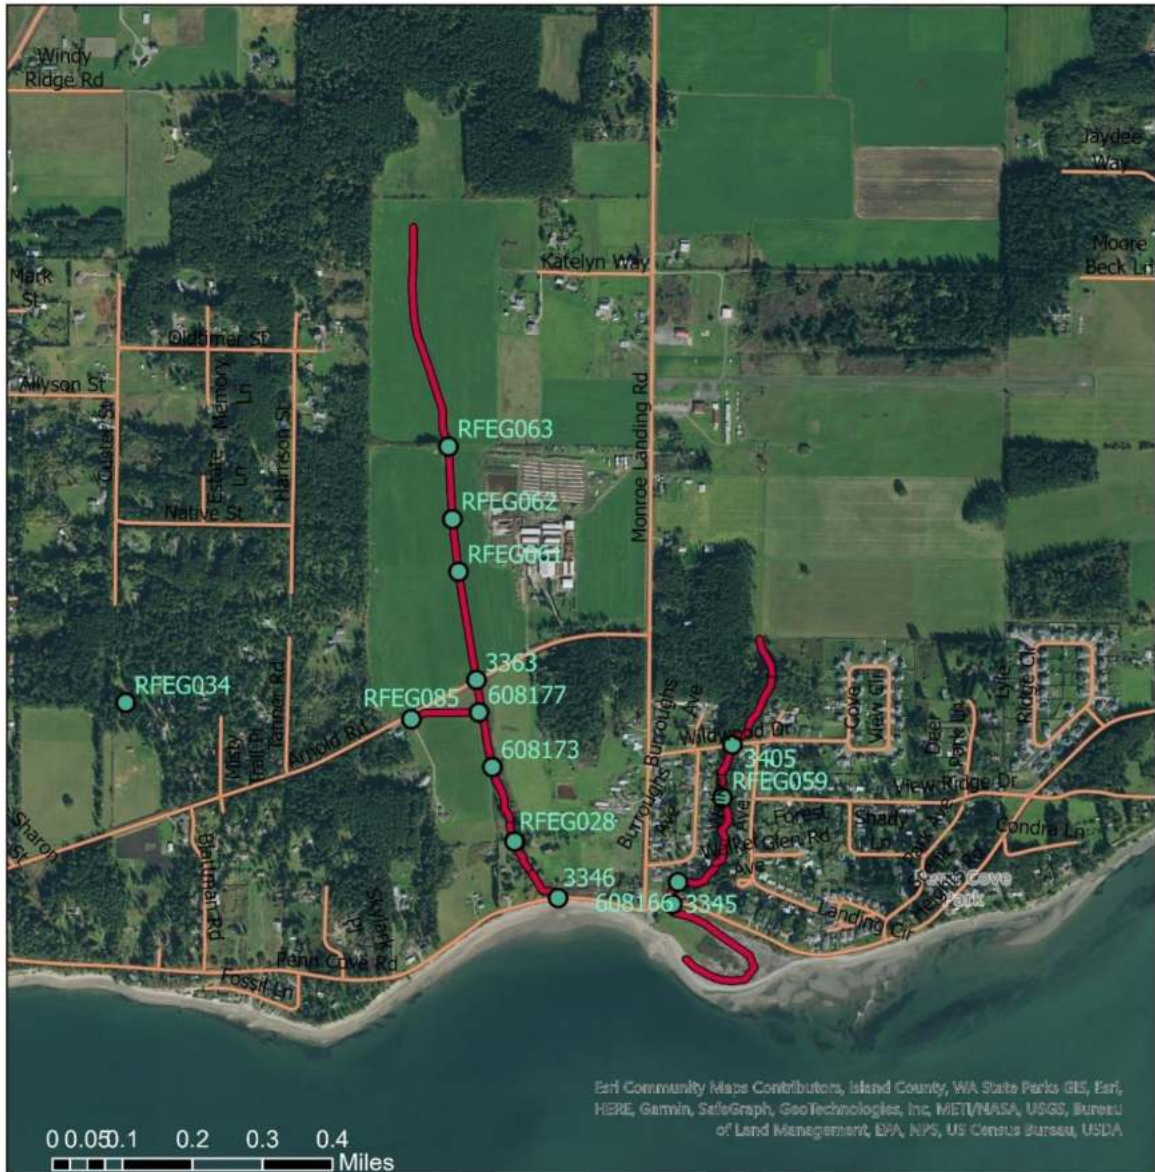
Figure 9: Monroe’s Landing Habitat Surveys overall. Eastern stream is an unnamed tributary to Penn Cove associated with county culvert number 3346. The western stream is an unnamed tributary to Penn Cove associated with county culvert number 3345.

Figures 9-12 show overall reach locations and culverts for the six streams habitat surveyed in this project phase, more detailed maps can be found in Appendix E of this report.

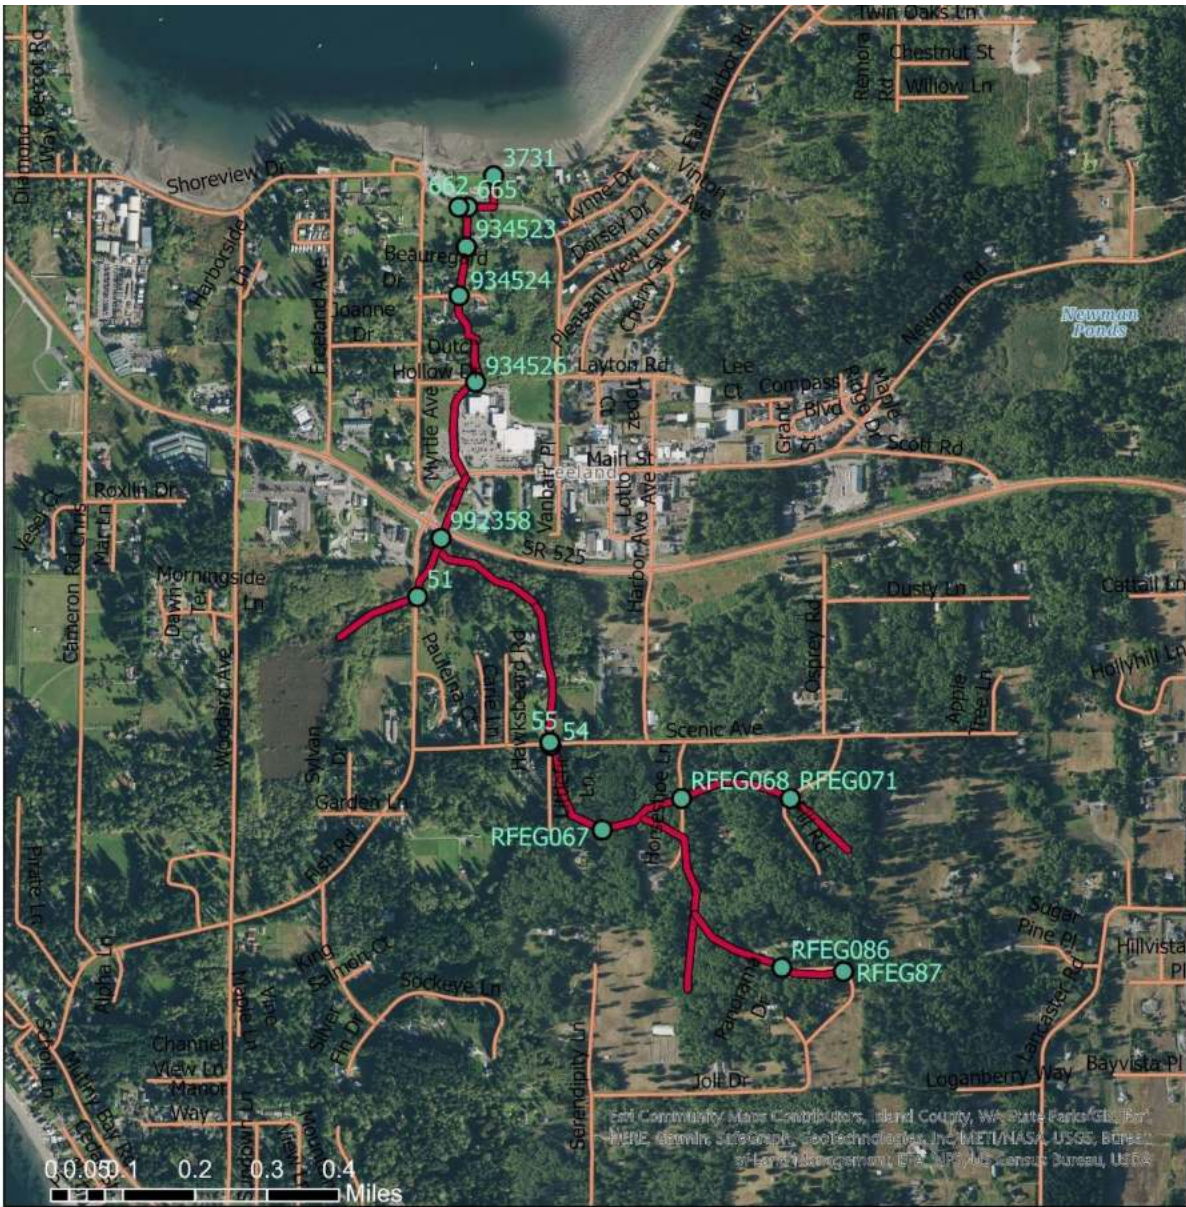
Figure 10: Freeland Creek habitat survey overall map.

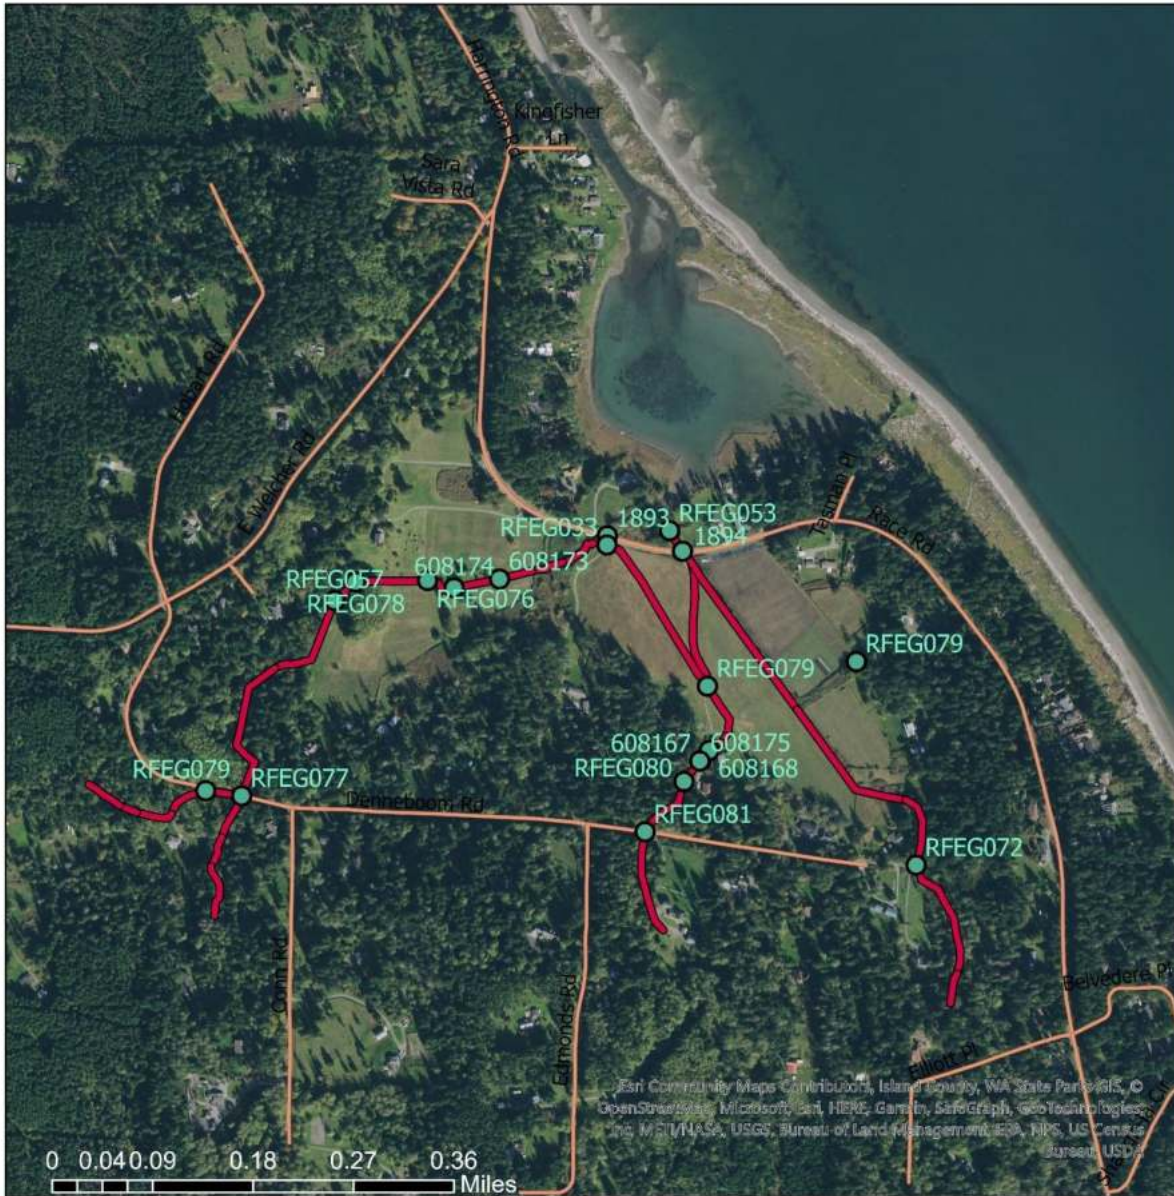
Figure 12: Two Race Road stream Surveys overall. Eastern stream is an unnamed tributary to Race Lagoon associated with county culvert number 1893. The western stream is an unnamed tributary to Race Lagoon associated with county culvert number 1894.
