City of El Segundo Recreation, Parks and Library

Subject: Pine Tree, Library Park

LIBRARY PARK
Certified Arborist Report

February 19th, 2025

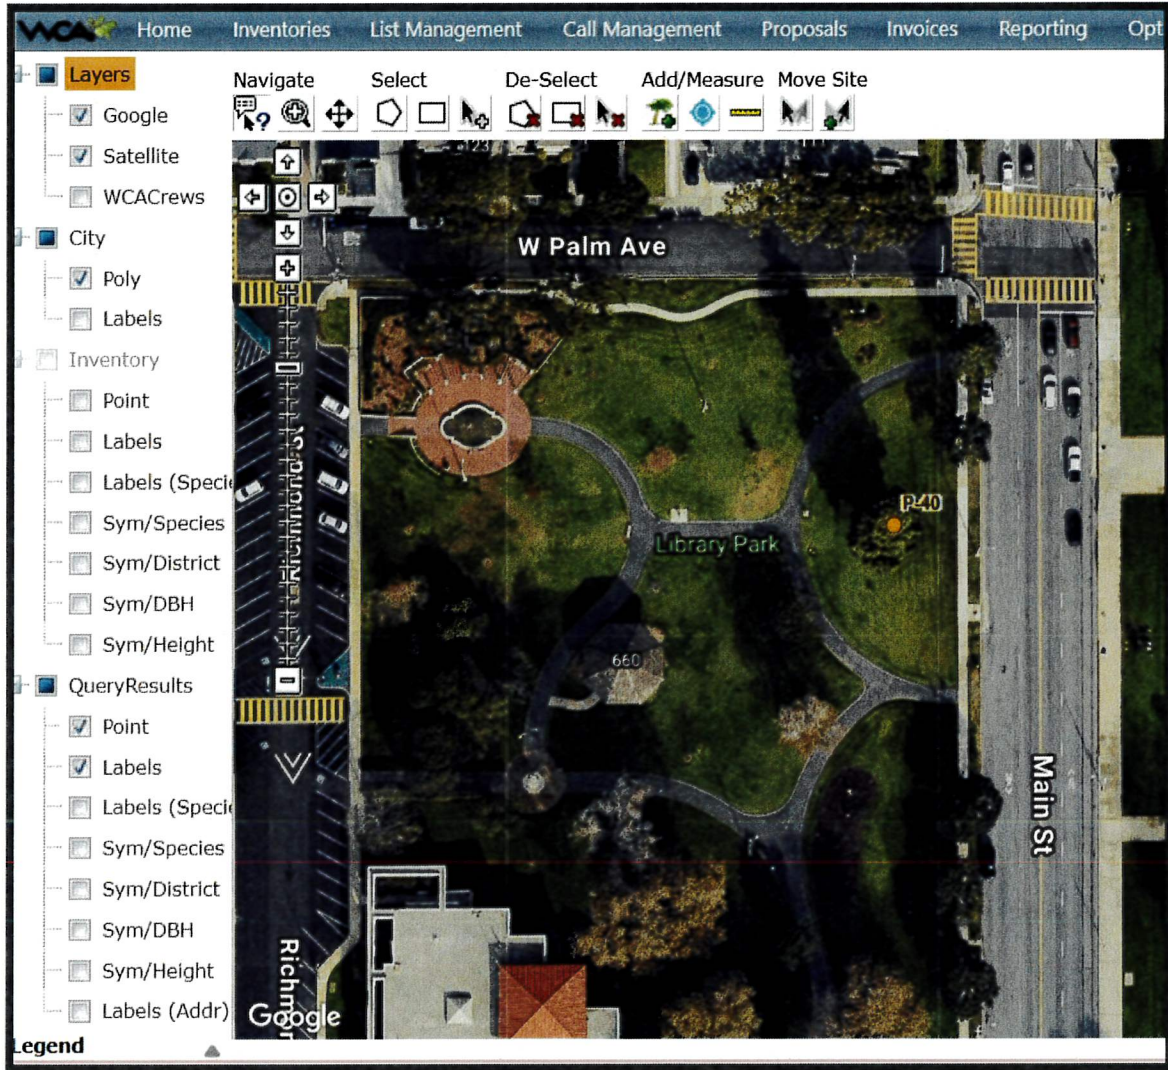
Map 1: The location of the subject tree P-40 at Library Park.

The inspected tree included one Canary Island Pine tree (P-40) which began to exhibit signs of decline in May 2024 per the use of google earth satellite imagery and verbal confirmation from the city. The focus of this general health assessment was to report on the overall health and provide maintenance recommendations. The majestic 95-year-old pine tree is over 60 ft tall and has a DBH of 42 inches, it is situated at Library Park, near Main Street in a grassy open space. Unfortunately, the majority of the canopy, approximately 80%, is dead and the tree will most likely not regain health.

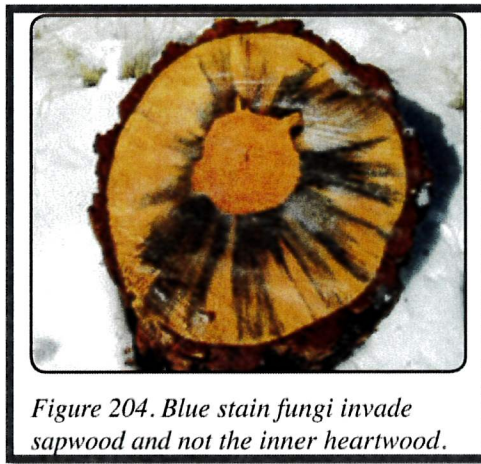
APPENDIX C- SPECIES PROFILE

Blue stain fungi are carried by bark beetles and other wood inhabiting insects and are associated with tree mortality. They are mostly blue-staining and primarily from the genera *Ophiostoma* and *Ceratocystis*. The spores germinate and produce a mycelium (thread-like mass) that colonizes the phloem and sapwood, eventually blocking the water-conducting columns of the tree. The formation of a wedge-shaped stain is due to movement of hyphae along the rays from the outside of a log. Stain fungi often hasten the death of trees attacked by bark beetles. The stain may result in a reduction in the value of timber or timber products by discoloring sapwood but does not affect wood strength.
